IECA Photo Gallery

# IECA Members Team Up To Tackle Colorado' Hayman Wildfire Erosion Control

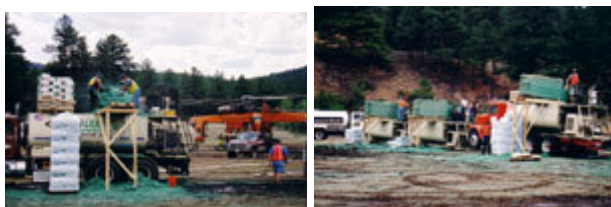
The Erickson Air-Crane helicopter lands at the staging area. Note 10,000 gallon white holding tank from which the 2,000 gallon slurry tank on the helicopter is filled from an 8 inch pump. Five hydromulchers feed the holding tank.

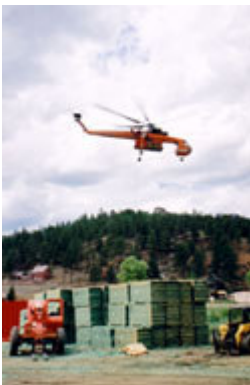
A back up 8-inch pump stands by if needed to avoid any lost production time.
