Applied Polymer Systems, Inc.

Innovations

In Soil Stabilization

US Highway 98 Summer 2005

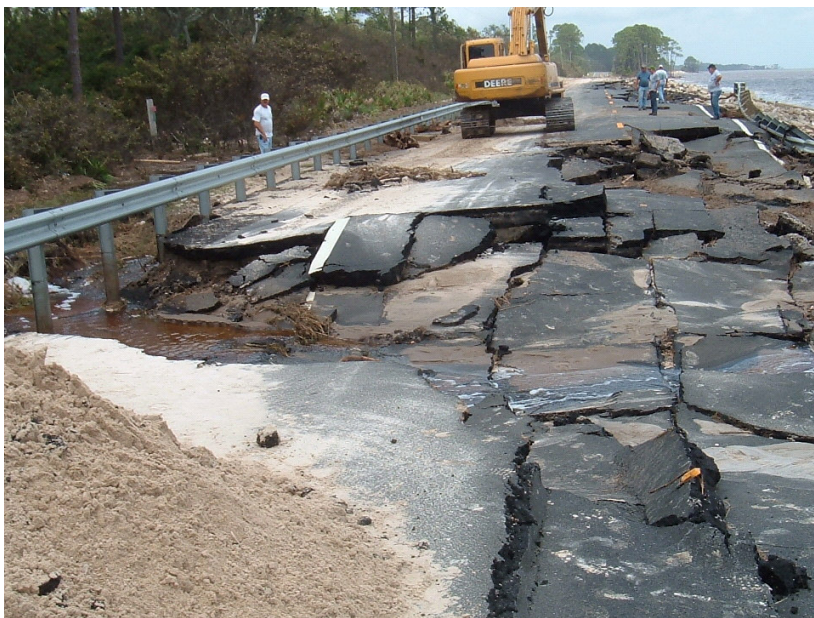
The movement of the highly erosive beach sands caused the roadway to collapse, in some places across the entire width of the two lane road.

Damage was severe on approximately 14 miles of US highway 98, ranging from erosion of the shoulder to buckling and subsidence of the entire roadway. Immediately after the storm, the Florida Department of Transportation (FDOT) took action to reconstruct and open traffic on the stretch of damaged highway, awarding a construction contract to complete emergency repairs within 14 days. The travel lanes were quickly reconstructed and traffic soon resumed; however, within a month shoulder erosion was reoccurring, threatening to again encroach on travel lanes.

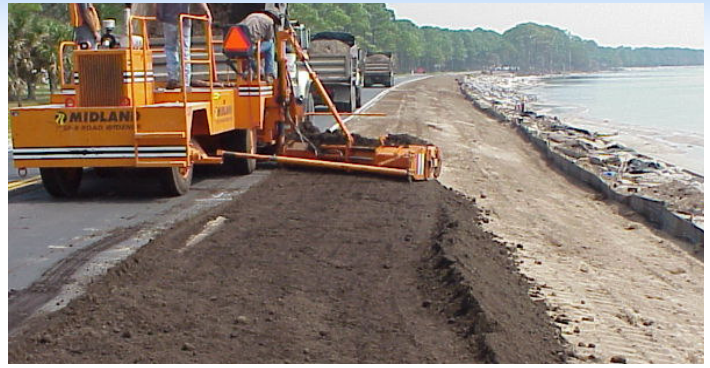
Right: A layer of compost material, covered with jute matting and Silt Stop powder, was applied before laying the sod.

Once the shoulder area was regraded, two inches of nutrient-rich compost material was spread out. This compost layer provided the necessary nutrients to help establish and sustain the soil-stabilizing vegetation.

Over the layer of compost, open-weave jute matting and the correct soil-specific APS 705 Silt Stop powder was applied at a rate of 50 pounds per acre. Bermuda grass sod was laid over the jute matting. The jute matting provided an initial attachment surface for the polymer powder, which immediately bound to the surrounding soil and compost layers, instantly creating a highly erosion-resistant matrix that provided structural support while the vegetation was established.

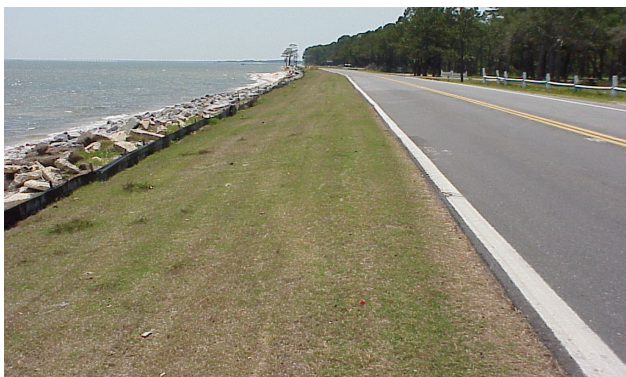
The shoulder of Highway 98, over 8 months after the application, is still stabilized and has held up to the extreme weather conditions of the Florida coast.

Over one year later, in August 2006, the soft armoring technique is still performing well, requiring little maintenance and successfully mitigating coastal erosion. The application sustained two major storm events, a category 1 hurricane as well as a tropical depression, with total survival of the road. This single application had added savings to FDOT because it prevented the road from having to be rebuilt or repaired after these storms.

Over time, the jute blanket has biodegraded and the sod vegetation has continued to establish root structure into the underlying topsoil. The shoulder areas along US Highway 98 are so well stabilized that they can now be used as access to the waterfront without fear of erosion. The level of performance of this type of soft armor application far surpassed the expectations of FDOT.
