Innovations

In Soil Stabilization

US Highway 98 Summer 2005

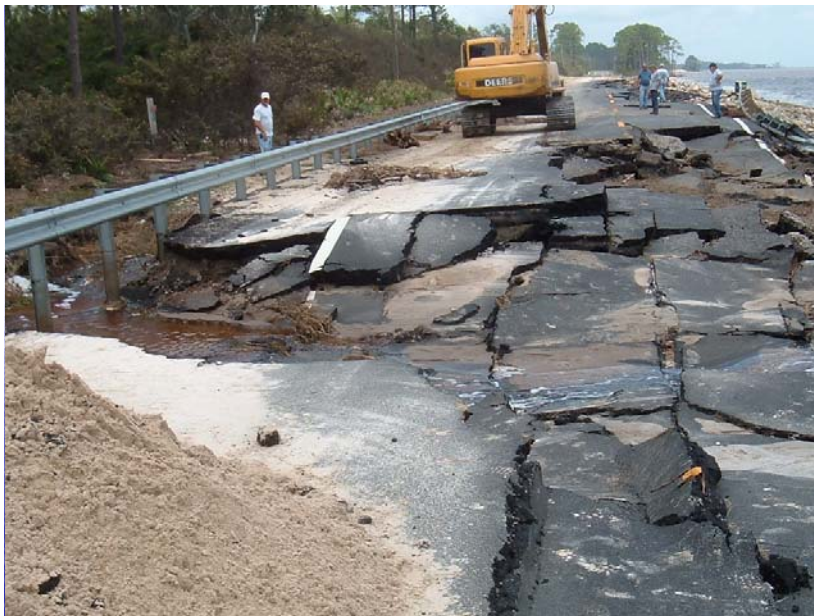
The movement of the highly erosive beach sands caused the roadway to collapse, in some places across the entire width of the two lane road.

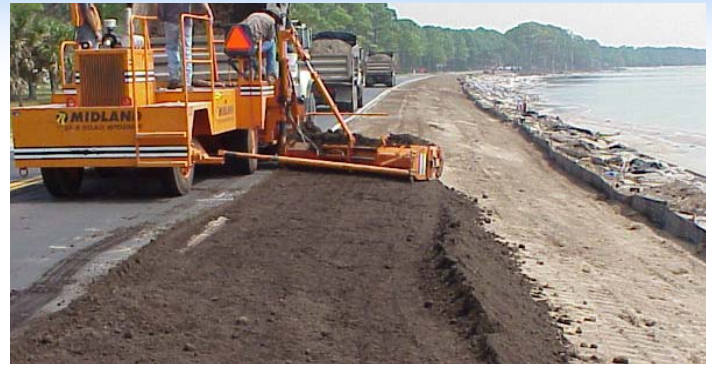
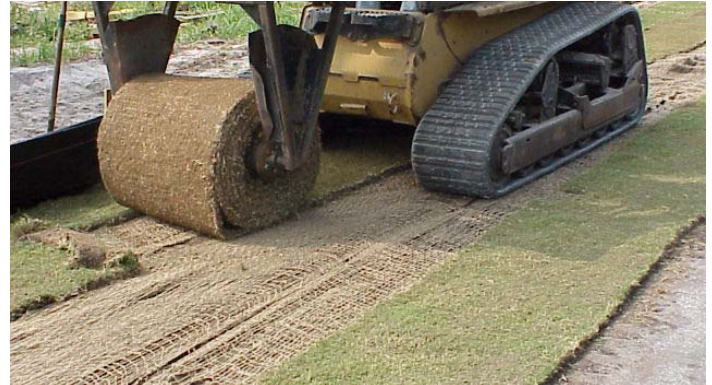
Right: A layer of compost material, covered with jute matting and Silt Stop powder, was applied before laying the sod.

Once the shoulder area was regraded, two inches of nutrient-rich compost material was spread out. This compost layer provided the necessary nutrients to help establish and sustain the soil-stabilizing vegetation.

Over the layer of compost, open-weave jute matting and the correct soil-specific APS 705 Silt Stop powder was applied at a rate of 50 pounds per acre. Bermuda grass sod was laid over the jute matting. The jute matting provided an initial attachment surface for the polymer powder, which immediately bound to the surrounding soil and compost layers, instantly creating a highly erosion-resistant matrix that provided structural support while the vegetation was established.

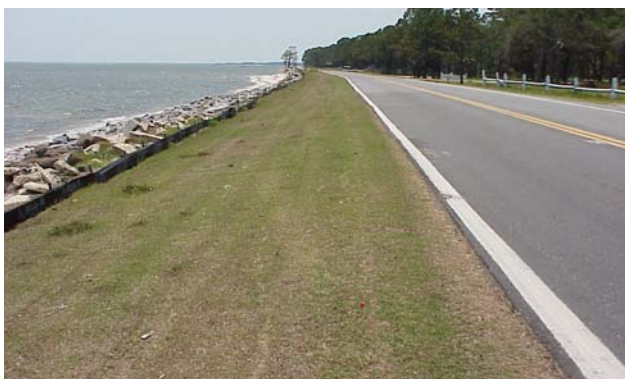
The shoulder of Highway 98, over 8 months after the application, is still stabilized and has held up to the extreme weather conditions of the Florida coast.

Over time, the jute blanket has biodegraded and the sod vegetation has continued to establish root structure into the underlying topsoil. The shoulder areas along US Highway 98 are so well stabilized that they can now be used as access to the waterfront without fear of erosion. The level of performance of this type of soft armor application far surpassed the expectations of FDOT.
