Innovations

Croft Pond at Nashville Zoo

In Erosion Control

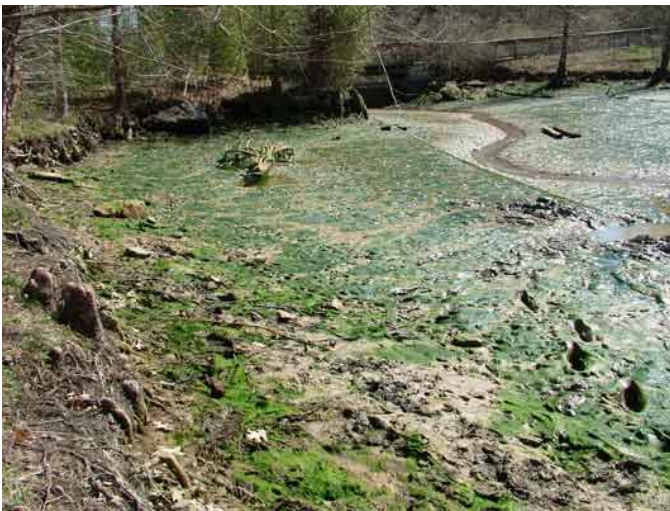
Croft Pond, once drained revealed 8 feet of sediment.

But before repairs could be made, the sediment needed to be removed. However, the soupy mess that was left at the bottom of the pond would be extremely difficult to remove with conventional methods. It was estimated that there was 7000 tons of sediment to be removed, covered by 3 feet of water. Kevin Surprise, of 5K Construction, found that large excavating equipment could not be used, as there was limited access to the pond due to the zoo's surrounding walkways.

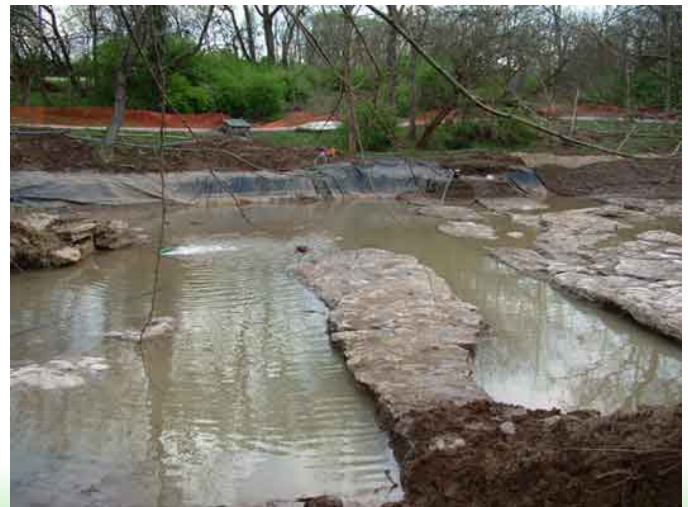
Even the small trackhoe that was brought in and placed on the bank had trouble. Between the muskrat activity along the banks, and the large crevices in the concrete bottom of the pond, it was too unstable to operate safely.

The uneven terrain provided a challenge to the machinery.

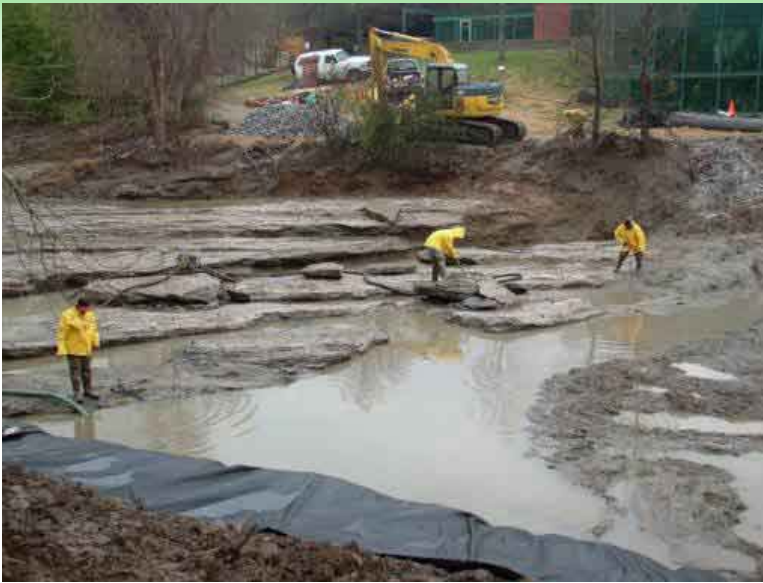
Pumping off of excess water to expose the sediment before removal.

To start, the upstream water was re-routed back into a wetland through the Zoo's pumping system, effectively creating a zero-flow environment at the pond site. Each day the pumps were started early and the clean water discharged over the Floc Logs to remove the suspended solids before diversion into a stormwater detention area, built with Jen-Hill flex max gabions, that had been constructed previously as part of the requirements for the Elephant exhibit. Floc Logs were also used to stabilize the spring-fed stream pouring the organic materials into the Croft Pond, as well as the stormwater ditch flowing into the site.

After 2 hours of dewatering each morning, sediment removal would begin on the areas isolated and stabilized using APS Silt Stop powder the afternoon before.

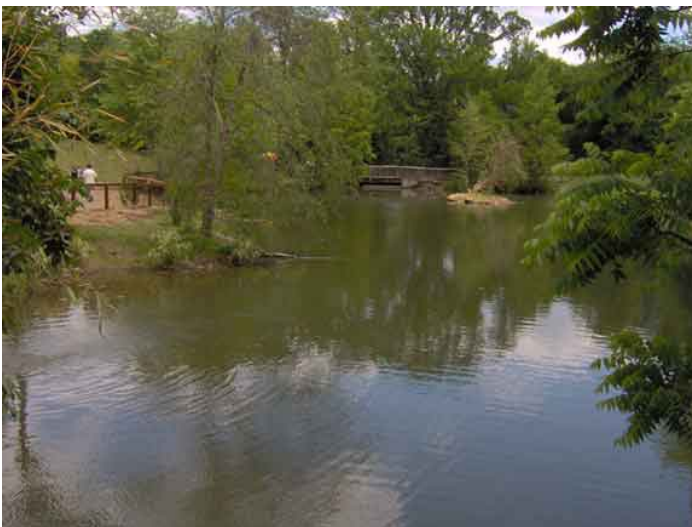
Project Complete: Croft Pond, fully restored.

After the sediment was removed, an island was constructed for the birds. Repairs to the dam were made with the GSE Polylock and a geo-membrane. This barrier prevents the pond from accidentally draining again, and protects the water from further off-site contaminates. Re-vegetation of the exhibit, overseen by Kelly Flora and Ben Moody, used native Riparian plants, special grasses, and wetland sod grown by Jen-Hill. The project was completed on time and on budget, allowing the pond to reopen as the new Black Neck Swan exhibit.

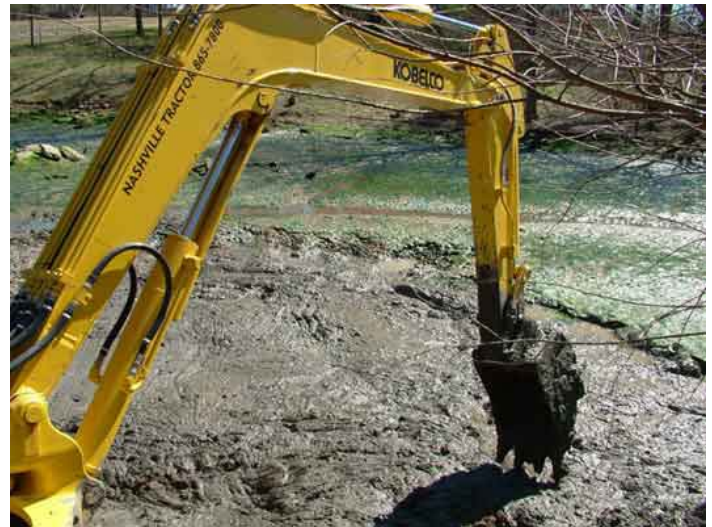
APS Silt Stop solidified the sediment for easier removal.

Occasionally the Silt Stop powder was added directly to the water surface and then mixed into the water and underlying soils by submerging a pump nozzle into the water and soils beneath thus solidifying the soils for removal. Once the muck had solidified, it could be easily scooped up and transferred into a single-axle dump truck and hauled away.
