Innovations

Bonnie Mine Road Project Summer 2006

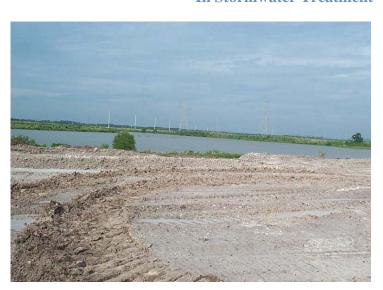
In the summer of 2006, Moretrench of Riverview was working on the Bonnie Mine road project in Bartow Florida when heavy seasonal rains threatened to delay the project. Excess water on the site had already been a problem, and dewatering operations were being used to manage the water onsite. With all the rains the retention ponds were near capacity and the water needed to be removed to continue operations on site. The pumping operations would have to be increased to accommodate the high volumes of added stormwater.

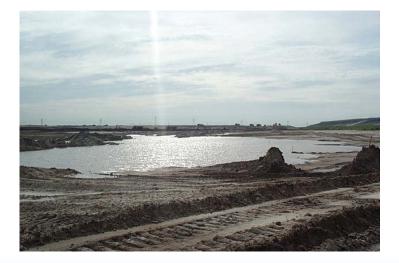
The rains had carried excess sediment into the retention ponds, causing turbidity problems. The excess water needed to be removed quickly, which did not allow time for the sediment to settle out of the stormwater. In fact the dewatering operations would stir up the sediment, causing elevated turbidity in the ponds and in the water to be discharged.

The turbidity created by the pumping operations and rainfall posed a challenge for the project to stay in compliance. Turbidity readings at the site were over 800 NTU, well above the allowable limits for discharge. Environmental impacts from turbidity plumes, avoiding fines for discharging out of compliance water, and potential project delays were the main focus for project managers on site.

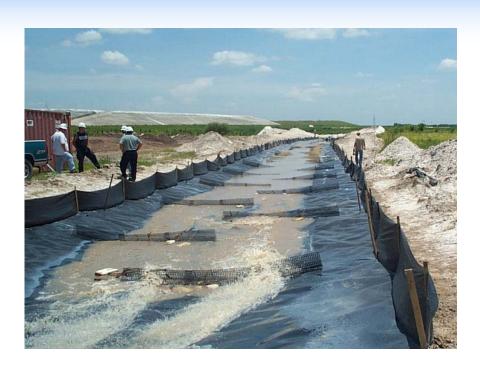
Moretrench contacted R. H. Moore and Associates, Inc. of Tampa to evaluate the turbidity issues and find a feasible solution. After going to the site and reviewing the operation it was determined that a continuous flow-through stormwater treatment ditch check system with APS Floc Logs would be the least intrusive and most cost-effective solution available, while allowing for a quick set-up and easy relocation as needed. Samples were taken of the turbid stormwater and sent for sitespecific testing to find the best Floc Log to use with the soil type present. It was found that the APS 703d and 703d#3 Floc Logs worked best on the site, along with the APS 705 Silt Stop powder. The testing provided site-specific results performance information, and showed that a duplex system would be required to drop the NTU levels and bring the project within compliance.

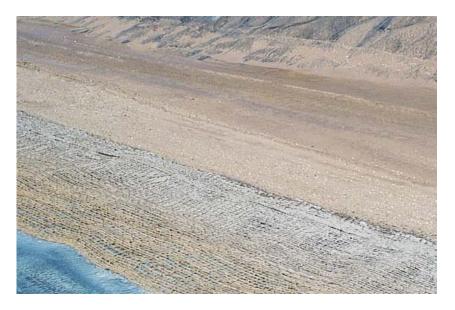
With this information, the stormwater treatment ditch could be designed. A long treatment ditch was created and lined with geotextile fabric to protect the underlying soil from erosion. Wire mesh checks were installed in the first portion of the ditch to facilitate mixing around the Floc Logs. The 703d and 703d#3 Floc Logs were placed around the checks where the turbid water would flow over and around them. The Floc Logs dissolves into the turbid water and reacts with the suspended sediment causing flocculation to occur.

Jute matting was installed at the end of the treatment ditch system and applied with the APS 705 Silt Stop powder. The jute matting provided a surface for the flocculated particles to adhere to and the 705 powder helped capture the fines still in suspension.

The stormwater treatment ditch with APS Floc Logs and powder allowed for continuous pumping and direct discharge off-site by dropping the NTU levels below 17, well within regulatory agency limits.
