**Restoration and Bank Stabilization Project at Poe Springs
Alachua County Florida
DEP Agreement No. S0202
Final Summary Report**

Restoration and Bank Stabilization Project at Poe Springs Poe Springs Park Spring Run Staircase Installation and Spring Head Staircase Extension

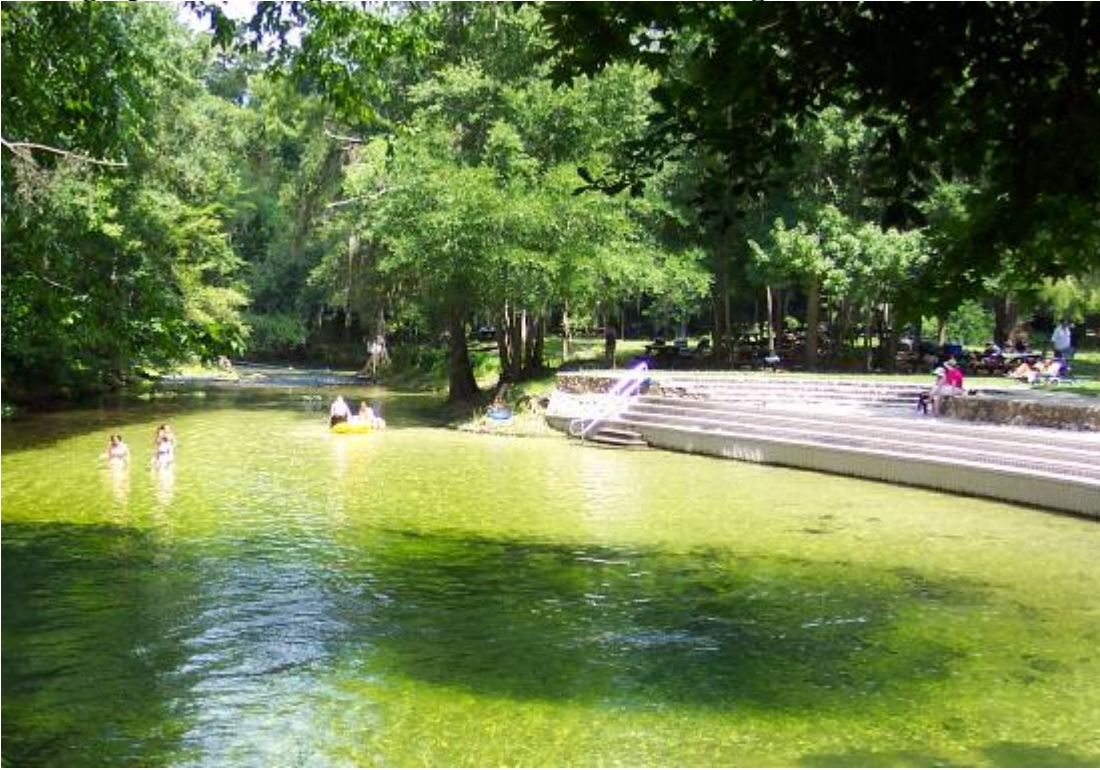
Photograph 1. Existing concrete staircase and retaining wall

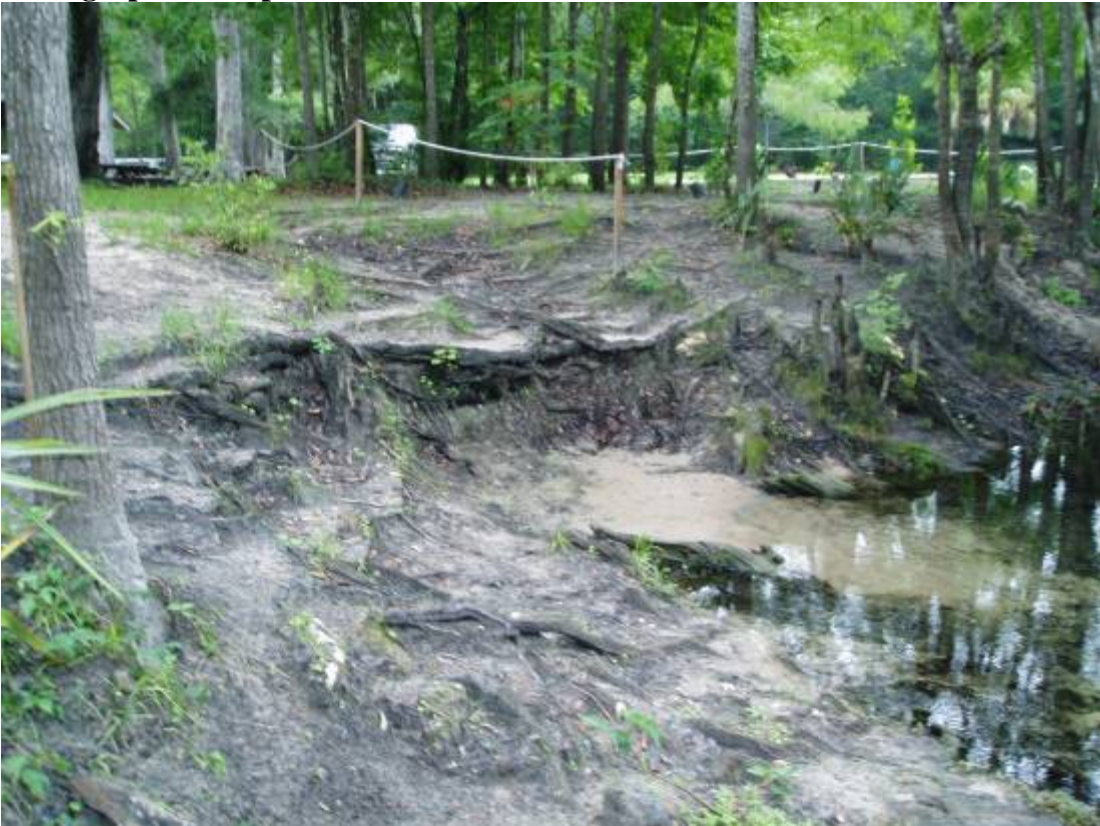
Photograph 2. Proposed location of staircase

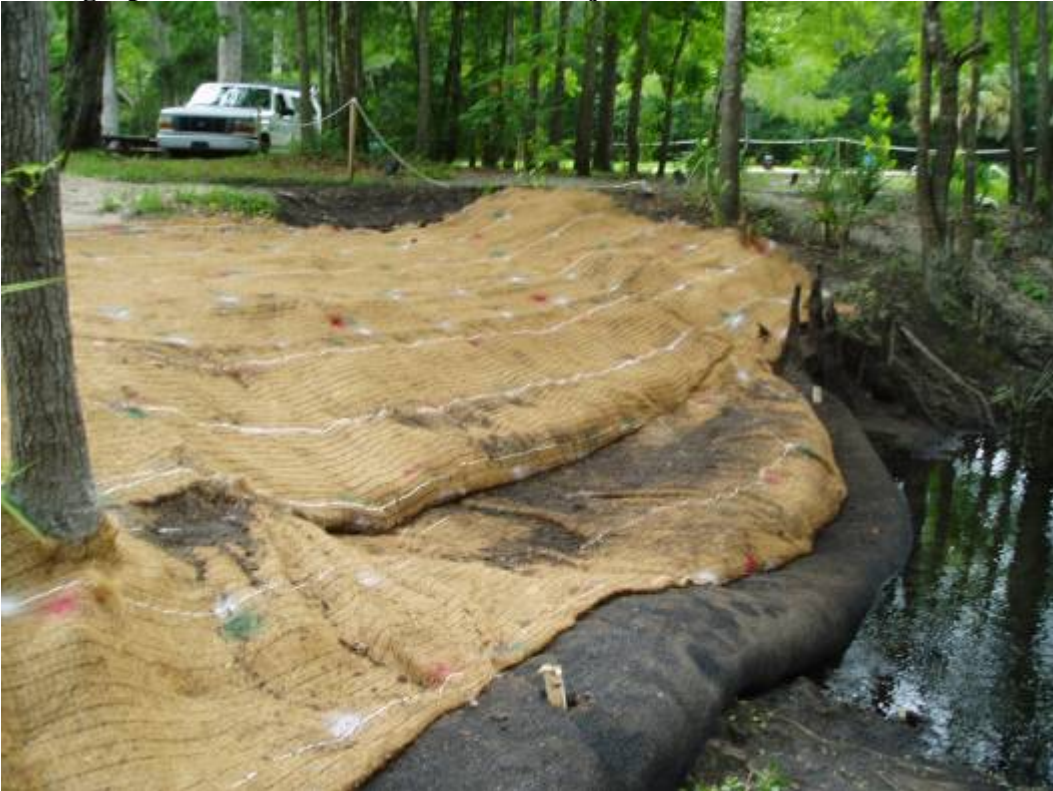
- Friday, June 10 - Decorator Mulch installed several Filtrexx socks to stabilize the toe of the slope and prevent further erosion and sedimentation into the spring run. A Filtrexx sock is a plastic mesh tube in which a mixture of composted tree debris and sand is sprayed. The compost has been lab tested to ensure that there will be no germination of unwanted plants or trees. The rest of the slope in the work area was covered in a jute fiber mat to prevent any further erosion of the bank (Photograph 3).

Photograph 3. June 10, Filtrexx socks and jute fiber mat

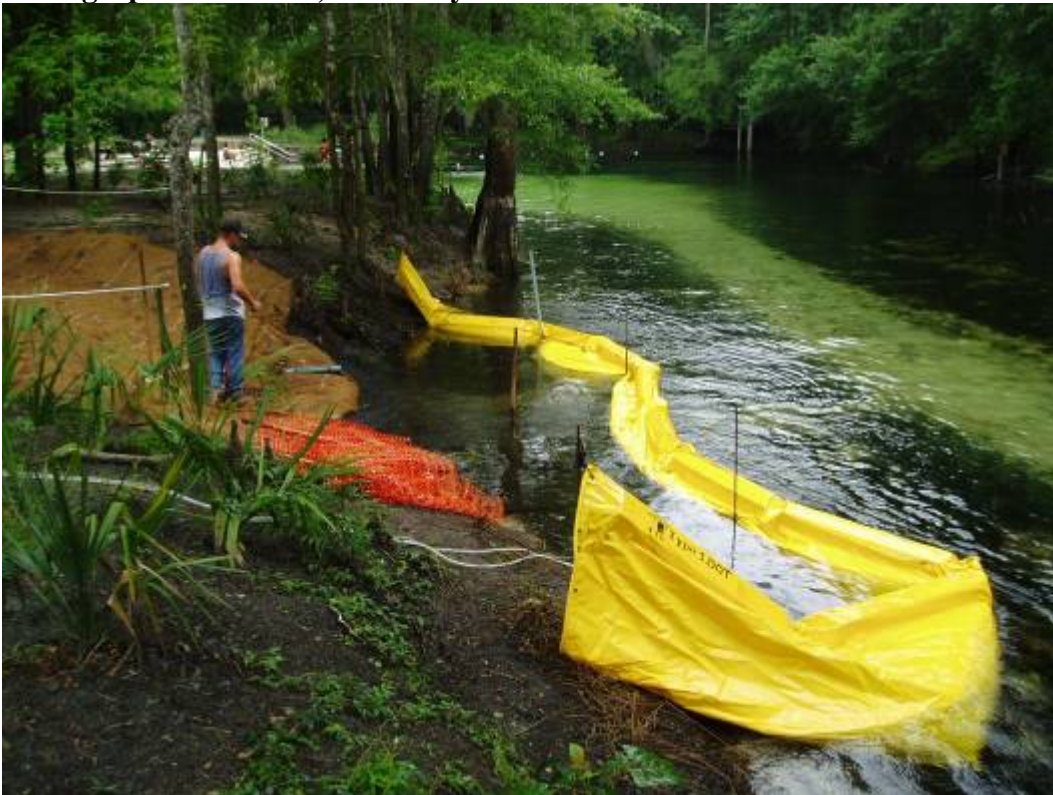
- Monday, June 13 - Patton Construction installed the turbidity curtain and began the layout of the staircase (Photograph 4).
- Tuesday, June 14 - the PVC pilings were installed and the structural framing was begun (Photograph 5). Structural framing was begun using ACQ treated wood.

Photograph 4. June 13, Turbidity curtain

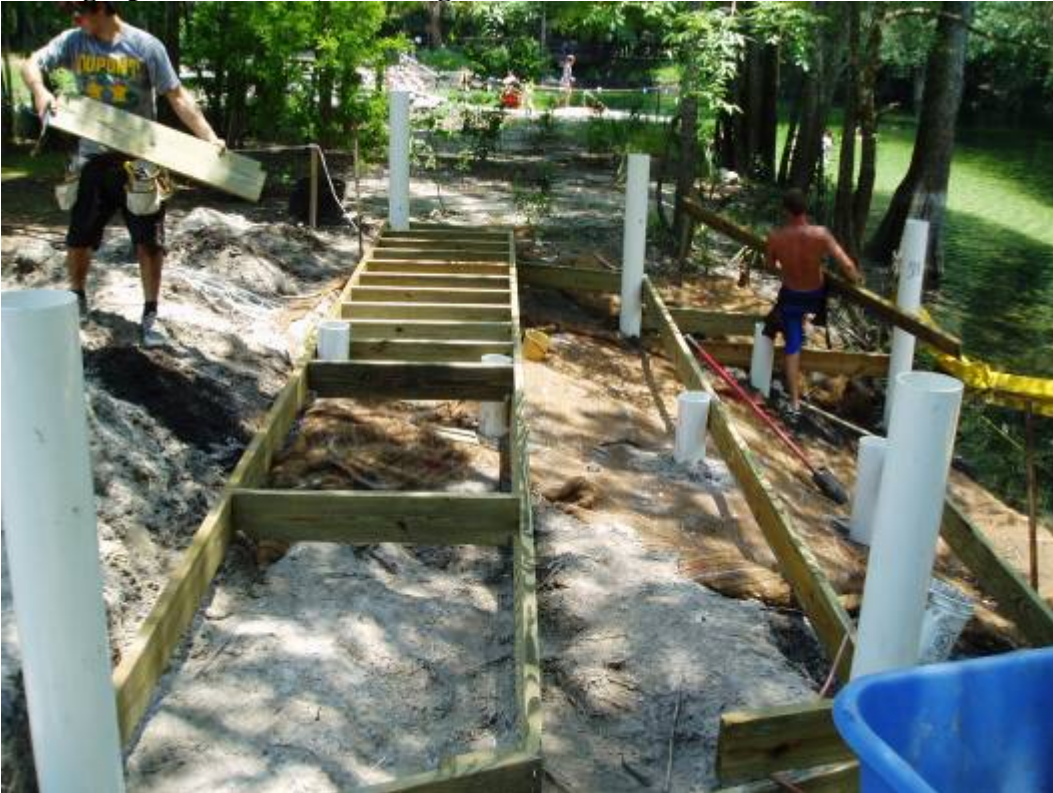
Photograph 5. June 14, Framing

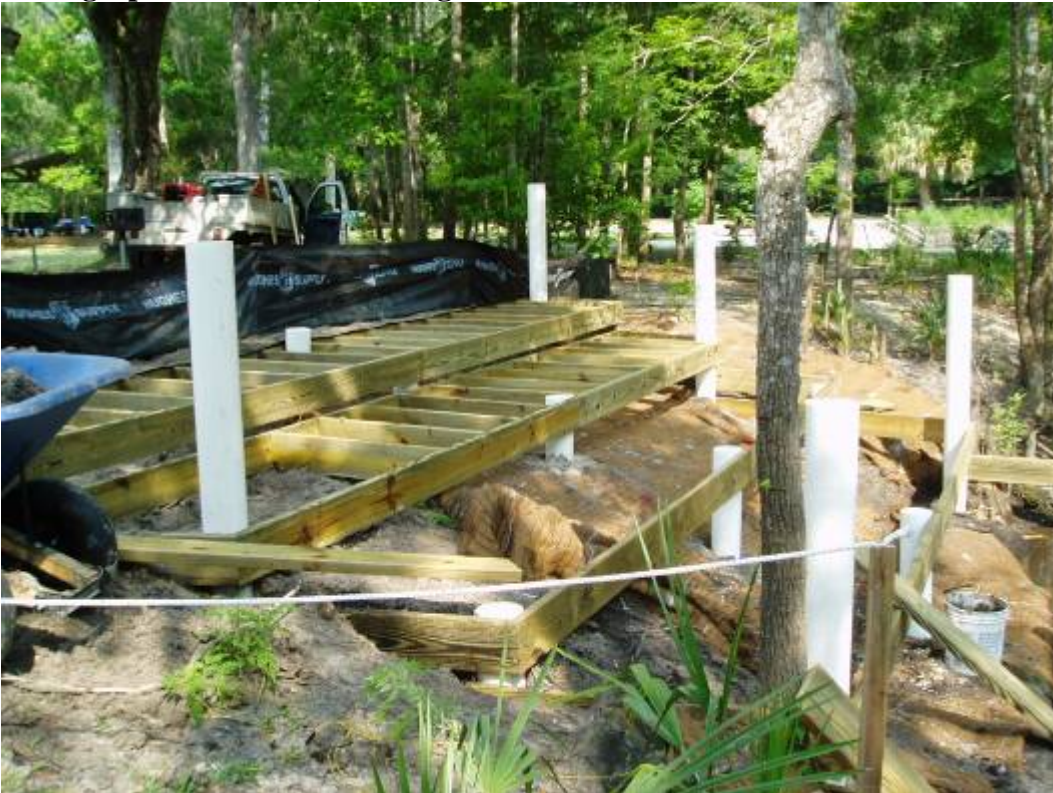
- Wednesday, June 15 - the framing was attached to the PVC pilings (Photograph 6). Photograph 7 shows the functioning turbidity curtain and photograph 8 shows the silt fencing that was installed to prevent offsite runoff from eroding the bank during construction.

Photograph 6. June 15, Framing

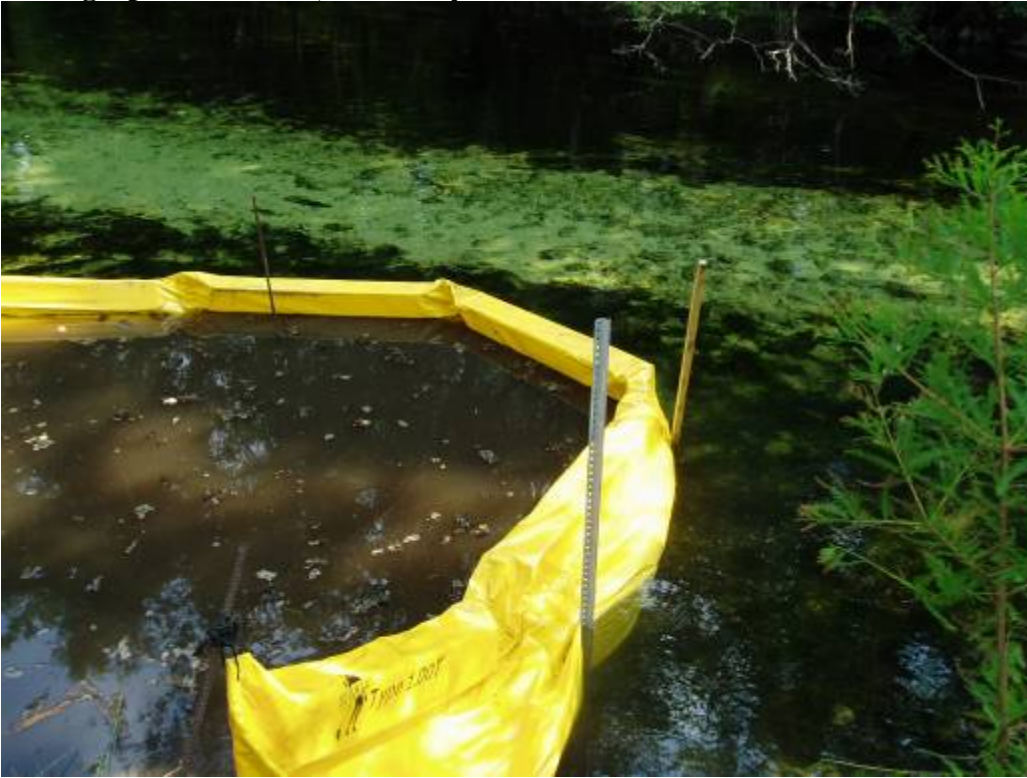
Photograph 7. June 15, Turbidity curtain

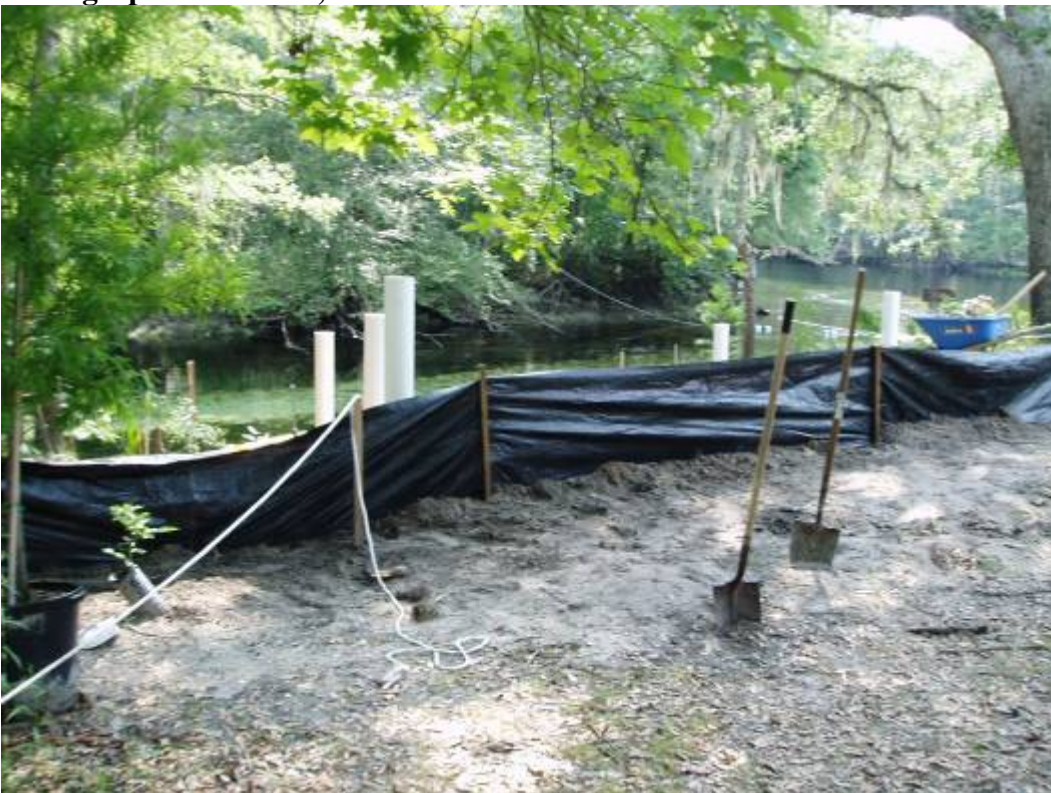
Photograph 8. June 15, Silt fence

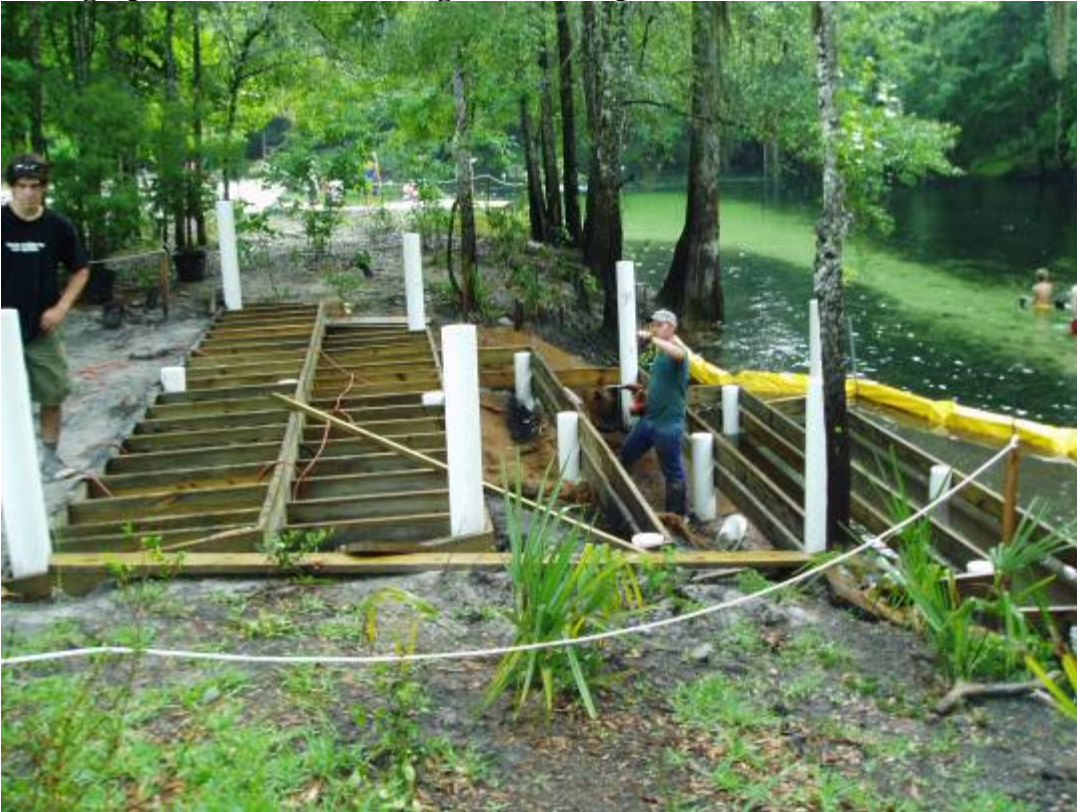
- Thursday, June 16 - majority of the stairway framing was completed (Photograph 9).
- Friday, June 17 - the framing was completed and the decking installation was begun.

Photograph 9. June 16, Framing almost completed

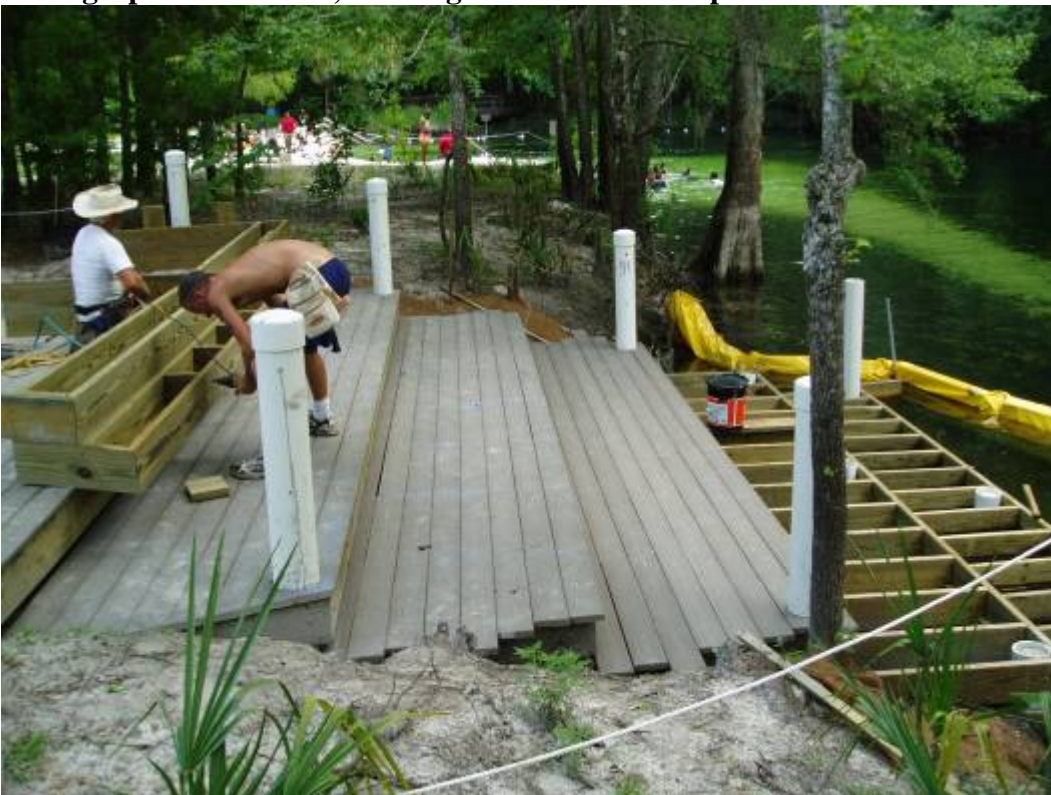
- Monday, June 20 - the decking was installed and the pilings were filled with concrete.
- Tuesday, June 21 - continued work on the deck and built cantilever steps for the lower two steps (Photograph 10).

Photograph 10. June 21, Decking and cantilever steps

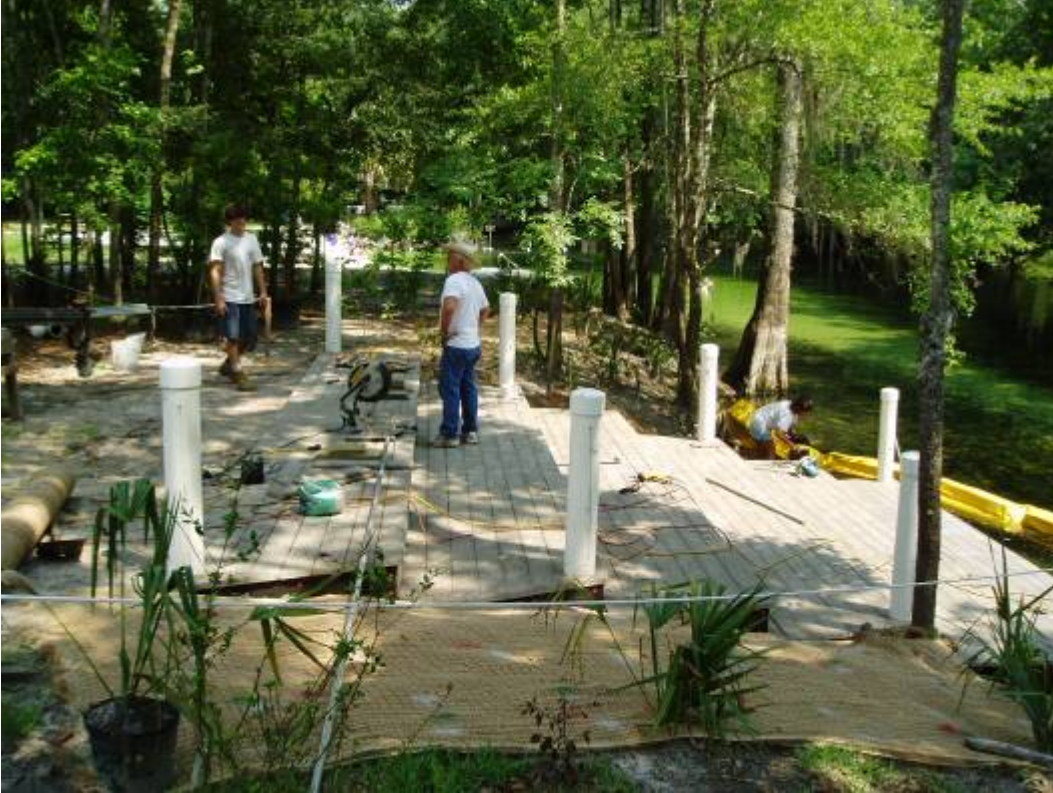
- Wednesday, June 22 - continued work on the deck and attached cantilever steps for the lower two steps
- Thursday, June 23 - the decking installation was finished, aluminum handrails were installed, the adjacent bank was covered with jute fiber matting and herbaceous plants were installed (Photograph 11).
- Tuesday, June 28 - the turbid water contained by the turbidity curtain was treated with a Floc-Log which contains a soil specific polymer that causes silt and clay to flocculate and prevents the colloidal solution from re-suspending. The Floc-Log is a registered product of Applied Polymer Systems, Inc. This product passes EPA/600/4-90/027F 48 Hr acute static toxicity test (*Daphnia magna*) and is listed under NSF Standard 60 Drinking Water Chemicals.

Photograph 11. June 23, Decking finished, handrails begun, jute fiber mat installed

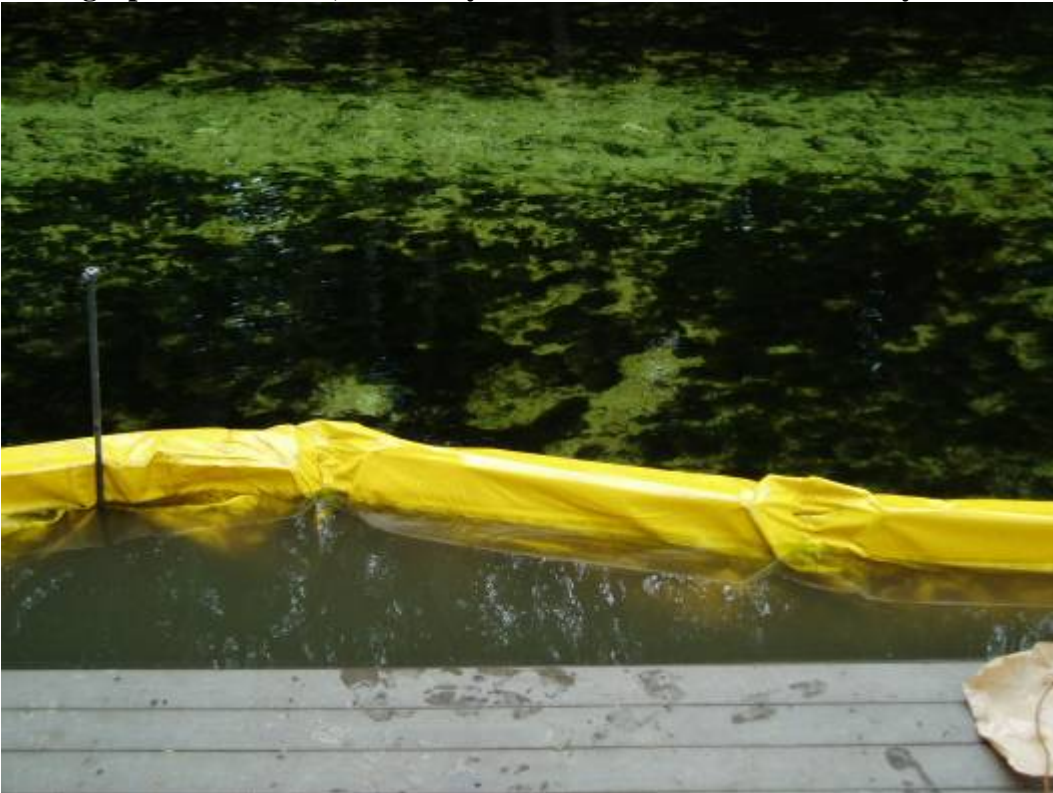
The turbidity behind the curtain was 93.4 NTU and the turbidity of the spring run was 0.25 NTU (Photograph 12). After the initial treatment the turbidity dropped to 32.8 NTU, an additional treatment was necessary to reduce the turbidity to 15.5 NTU, which is an acceptable level for the removal of the turbidity curtain. The turbidity curtain was re-installed at the spring boil for the installation of the additional stairs (Photograph 13). Two large cypress trees were planted on either side of the spring run staircase (Photographs 14 and 15). Photograph 16 shows the completed staircase.

Photograph 12. June 28, Turbidity inside and outside the turbidity curtain

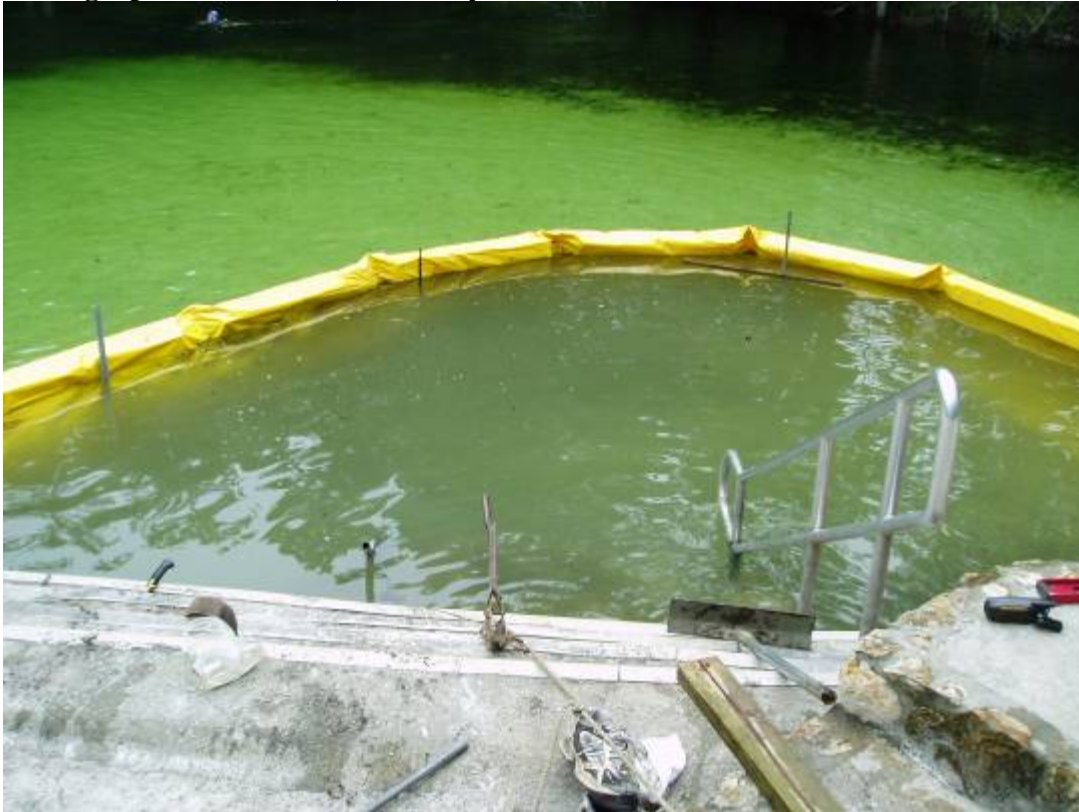
Photograph 13. June 28, Turbidity curtain for staircase installation

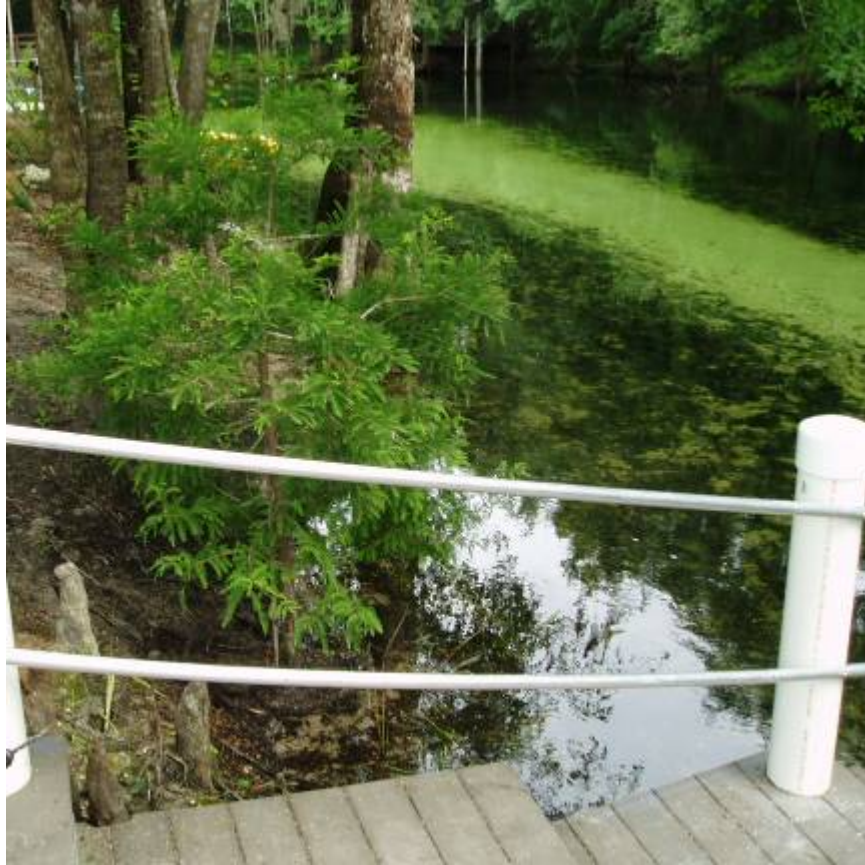
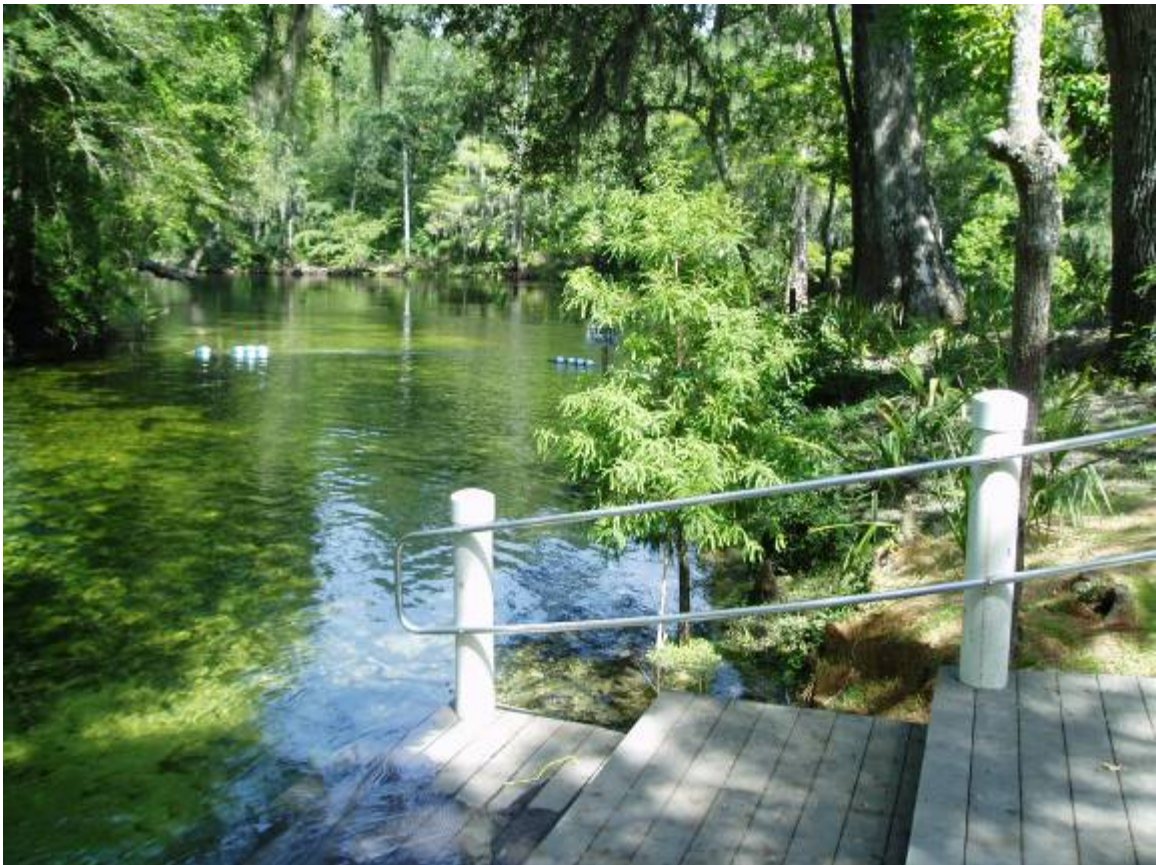
Photographs 14 and 15. June 28, Bald Cypress planted next to spring run staircase

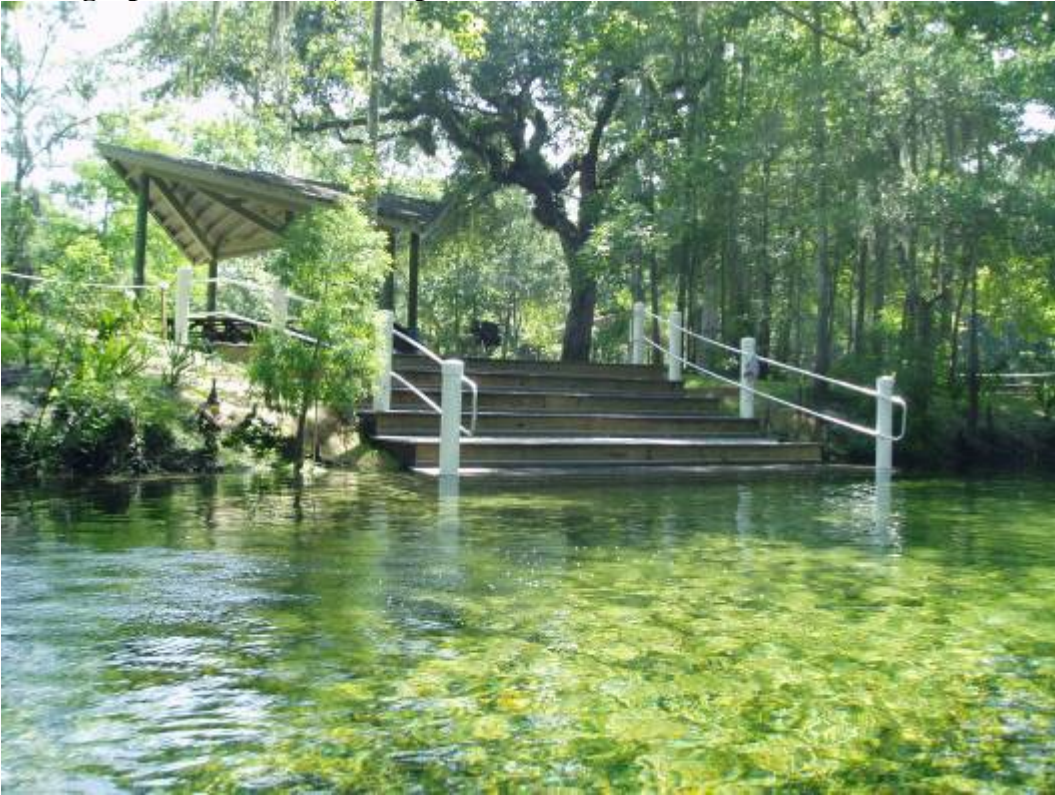
Photograph 16. June 30, Completed Staircase

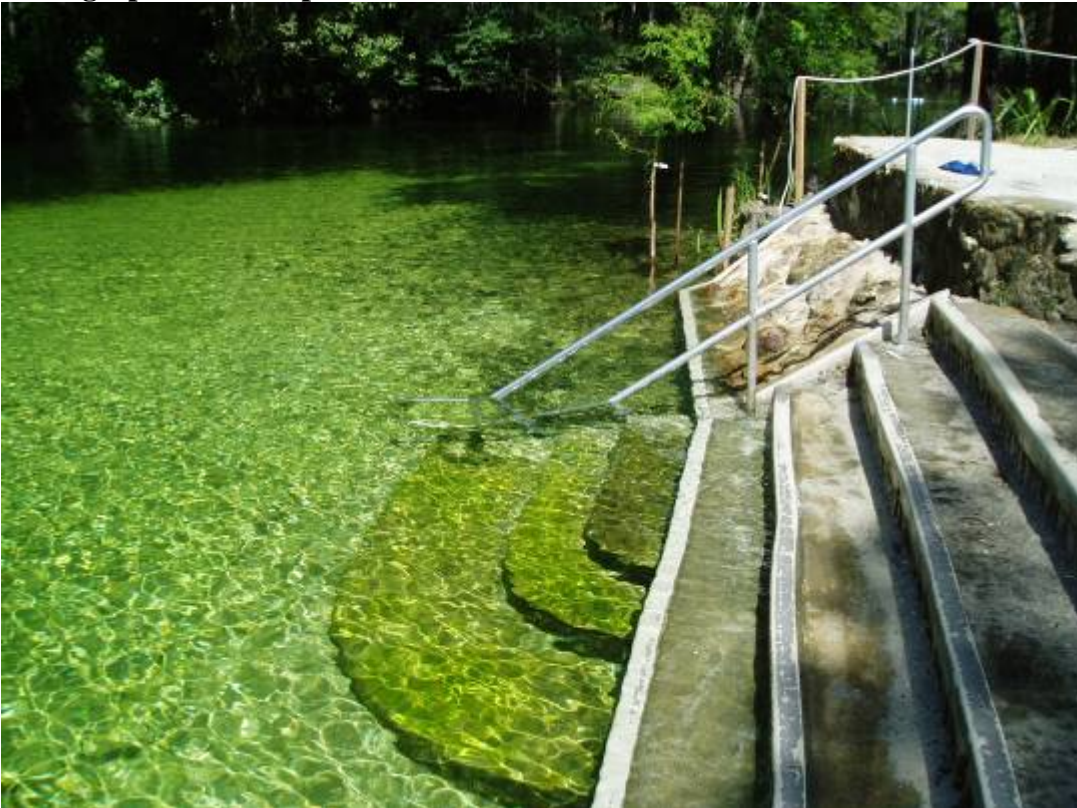
- Tuesday, June 28 - work on the existing stairways (2) at the main spring began. The existing stairs were undermined and had shifted away from the existing sheet piling wall. They were moved back into place and braced before completion of the new stairs. The forms for the concrete stairs were installed by the end of the day.
- Wednesday, June 29 - the concrete steps were installed and allowed to set overnight (Photograph 17).
- Monday, July 4 - visitors enjoy the newly completed stairway (Photograph 18).

Photograph 17. Completed concrete stairs

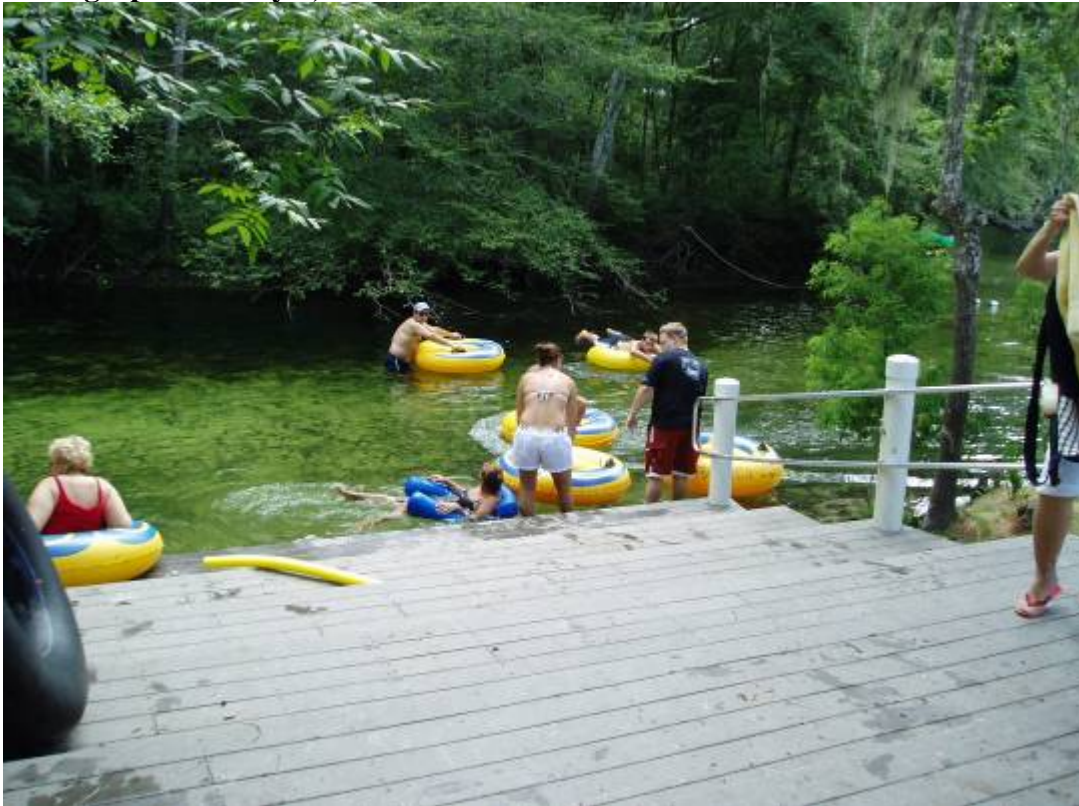
Photograph 18. July 4, Staircase in use

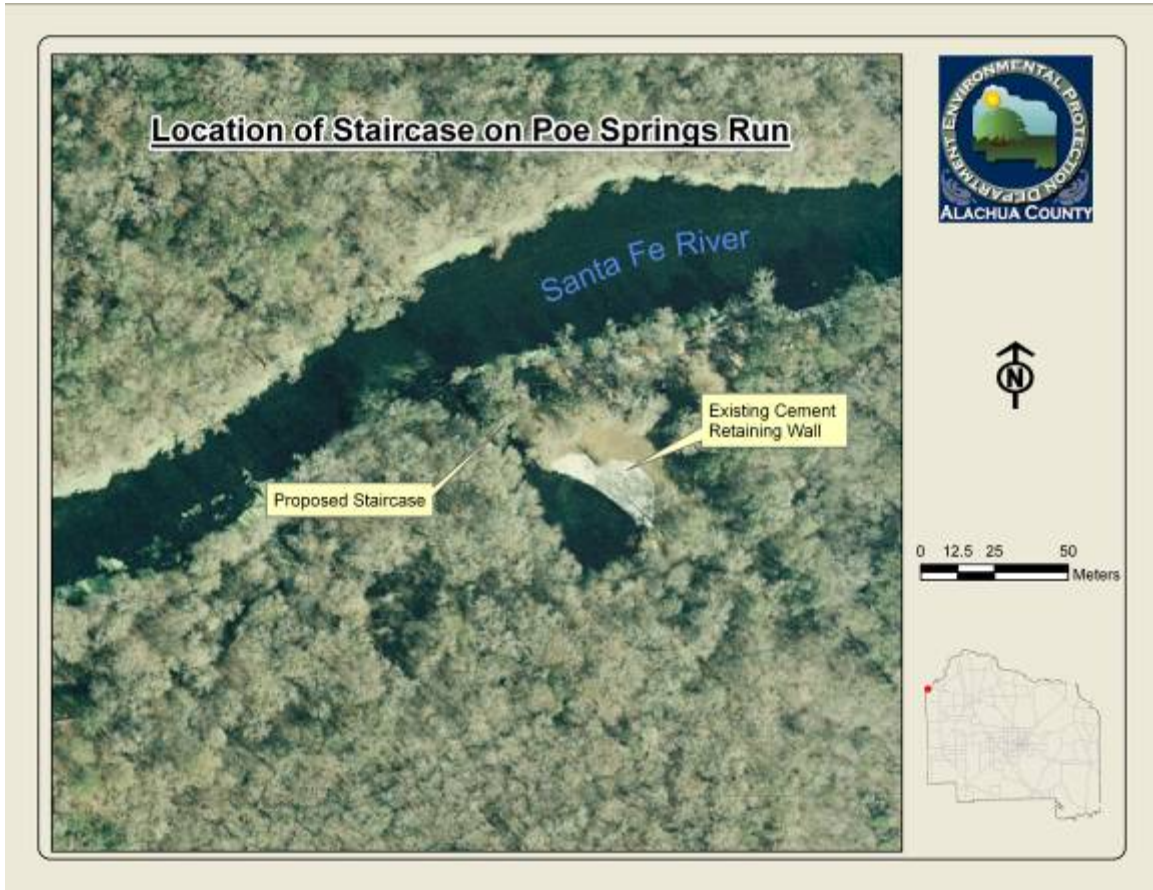
The final project is a fan shaped staircase on the spring run at Poe Springs Park to facilitate the visitors' access to the water (Figure 2). The staircase is secured to the bank using concrete filled PVC pilings with ACQ treated structural beams with the landings made of a plastic decking (i.e. TREX™). This structure will prevent further erosion of the bank and concentrate the foot traffic to one location instead of being dispersed throughout the riparian buffer as it has been historically.

Figure 2. Location of staircase in relation to spring
