Applied Polymer Systems, Inc.

Bank Stabilization

Lake Independence Dam – Bank Stabilization, Big Bay, MI

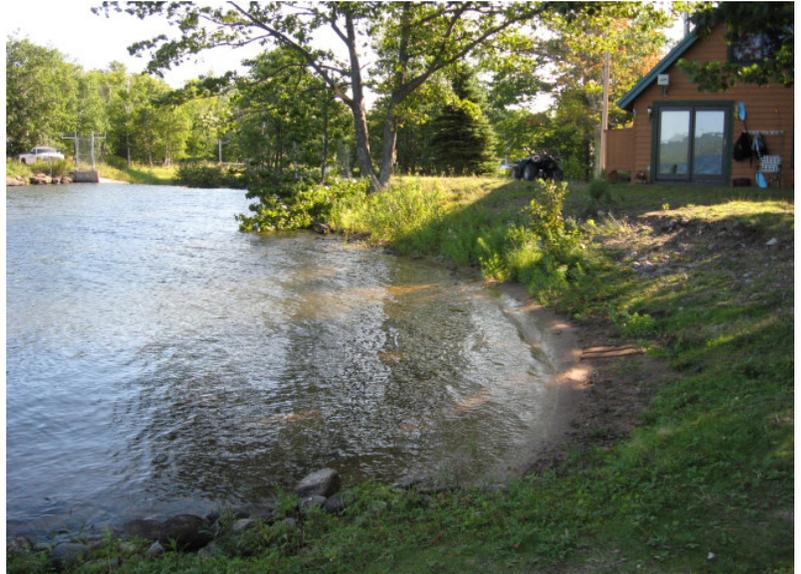
Erosion of the shoreline is clearly visible in the bank along the right side of this photograph. The dam is seen on the upper left-hand corner of the photo.

Through the years, substantial erosion has been occurring along the banks adjacent to the dam. Sand bagging was the normal practice to prevent scouring and channelization around the dam. It was feared that should erosion continue, the water would eventually cut a path around the dam, rendering it useless, and essentially draining the lake. This would alter the ecosystem as well as severely diminish property values along the lake.

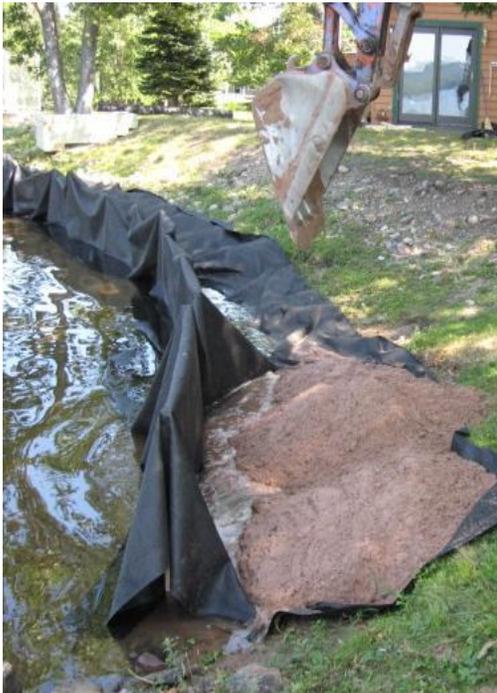
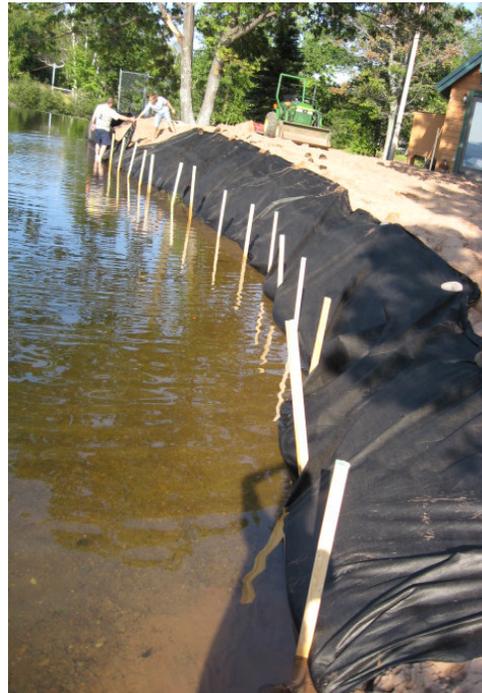
The photo to the left shows the geosynthetic fabric laid on the bank and the sand beginning to be deposited. The photo to the right shows the excess fabric being pulled over the sand and fortified with rock, forming a containment for the sediment.

The area was cleared of tall grasses and shrubs, and wooden stakes were placed at the low water line to establish a boundary. A non-woven geosynthetic fabric was then laid across the slope with enough overlap so it could be pulled over the soon to be added sand/soil material, forming a containment and preventing the fine material from washing into the lake. Once the sand was brought in and the geosynthetic fabric stretched over it, medium sized rock was used to fortify the newly contoured bank.

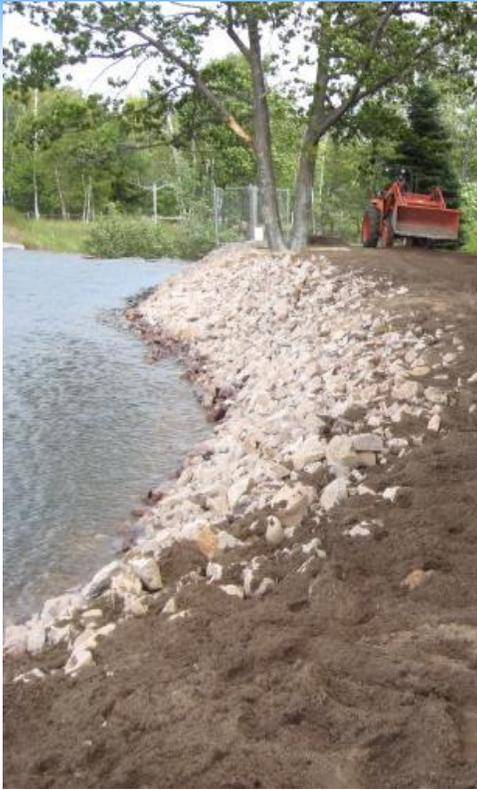
Left: Completed bank structure consisting of sand, rock, and top soil.

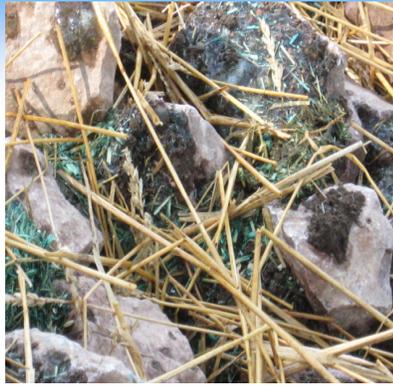
Right Top: Polymer, seed mix, mulch, and straw matrix spread over rock.

Next, a mixture of seed, mulch, and polymer was added to the rock bank. Establishing vegetation in rock and sand is very difficult. This was achieved using a seed mix of clover, perennial rye, tall fescue, and millet. The clover was used to produce nitrogen without the use of fertilizers. A site tested polymer, APS 705 powder, was used to bind all the materials together with the soil to form a matrix, keep it in place, and allow for a vegetative cover to be established.

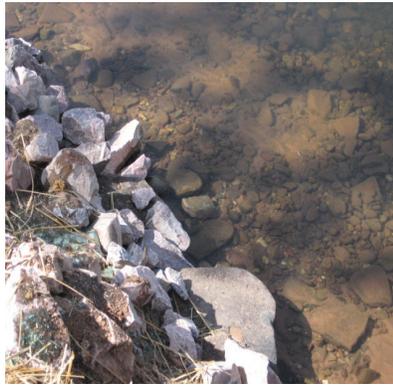
Right Bottom: Clear lake water directly below newly stabilized bank.

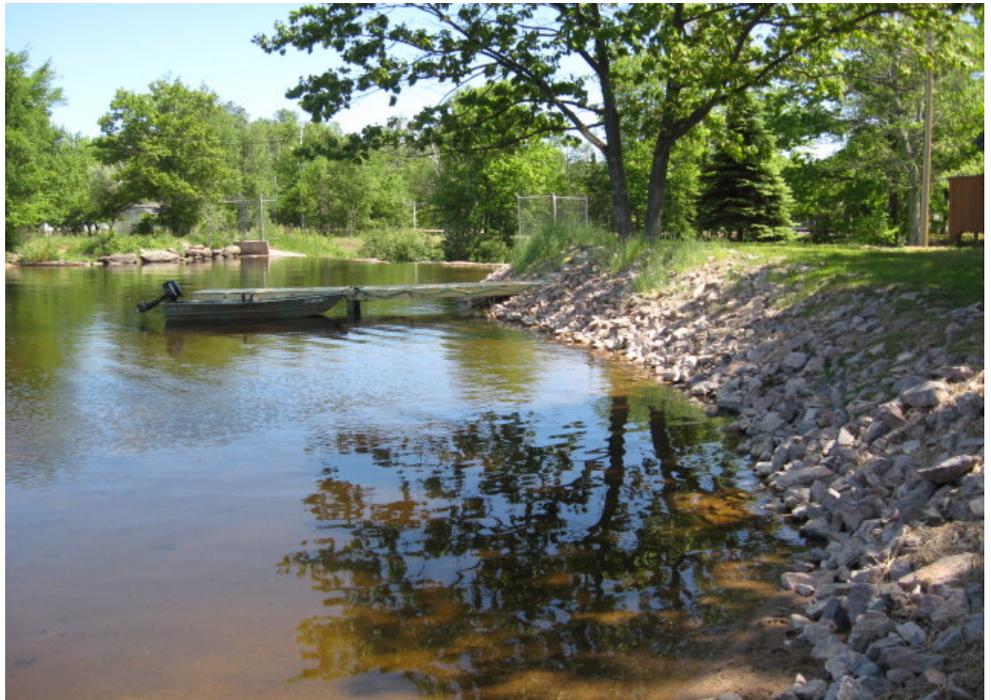
The following spring the bank was visually appealing and permanent. Note the grass growing between the rocks and the clarity of the water seen in the reflection of the tree..

The project took about two weeks to complete and the different types of grasses came up from within 3 days to 2-3 weeks. After a year, in the following spring, the grass continued to grow once again.
