Applied Polymer Systems, Inc.

Jim Berry Pond

In Pond & Lake Management

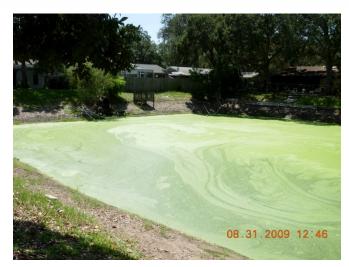
Berry Pond is 0.45 acre in size and approximately 5 feet deep. As the picture to the right clearly shows, the pond was completely covered in duckweed and watermill. Despite the fact there are two aerators and a fountain that ran every day, the pond had experienced several fish kills as a result of low dissolved oxygen levels over the past two years.

Above: Initially Berry Pond was 100% covered with duckweed and watermill

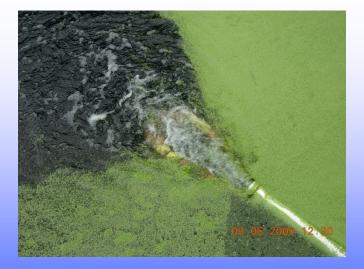
Below: One week after the installation of the APS 806 Pond Log there is a visible difference.

To clean the pond, a LIPVAC circulation system was installed with Applied Polymers Systems, Inc. 806 Pond Log Links. LIPVACS stands for Low Interior Pressure Venturi Aeration Circulation System. According to Eco-Pond Rescue's website, the venture system is designed to operate on high volume but with low pressure. This allows the pump to operate at a high efficiency reducing electrical costs. In addition to the LIPVACS, APS 806 Pond Logs were installed in Berrv Pond.
