When a South Hadley condominium developer and contractor were fined \$50,000 for water violations of the FOC and Massachusetts State laws, they were recommended to contact Mark Thrum with Hydrograss Technologies to help clean up their site.

South Hadley, MA Winter 2005 – Spring 2006

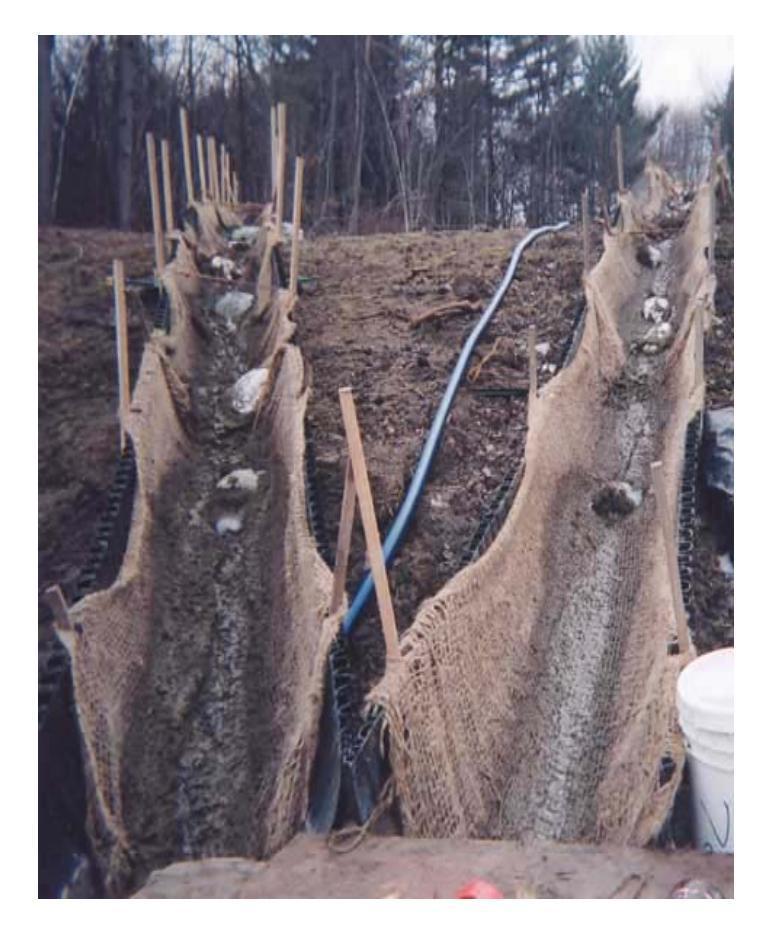
The water was pumped out of the sediment pond up to the top of the hill and fed into a pair of split pipe water treatment systems.

The Floc $Logs_{\textcircled{O}}$ were placed at the top of the pipe and the water flowed over them down the split pipe lined with three layers of jute matting before reentering the pond. After a site visit and some discussion, it was decided to install two 100 linear foot split pipe Floc $Log_{\textcircled{B}}$ flocculation systems to feed into the concrete storm box. The split pipe system consists of a 36" diameter HDPE pipe cut in half and connected by male/female connections. Pitch can also be used to waterproof the pipe section seams, though it was not used here.

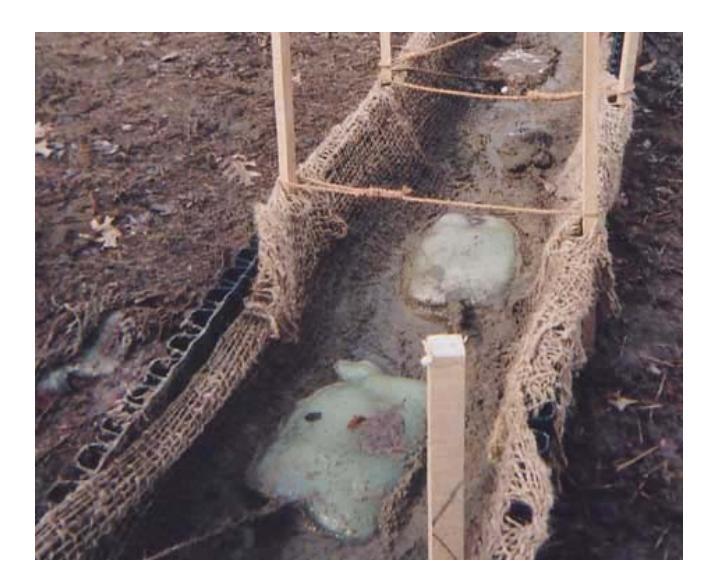
The Floc $Logs_{\textcircled{O}}$ were secured along the treatment pipe using the stakes that held the split pipe in place.

The entire length of split pipe was coated with three layers of coir-jute erosion control matting. The coirjute matting is a very loose weave material that can easily be draped over the wooden stakes fitted into the split pipe slots to hold it in place. Since the matting acts as a filter and surface area, allowing the flocculated material to adhere to it, care was taken to assure that the matting was hanging in the water flow.

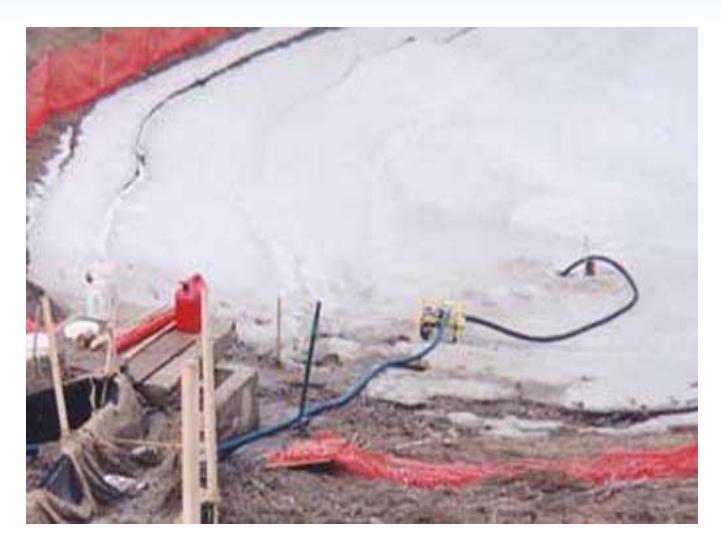
Even in frozen conditions, this system could be run. Reaction times are prolonged with colder temperatures, however the Floc Logs_® still work.

A hole was cut in the ice to allow the pump-feed to draw water out of the pond. The water was pumped up the hill before reaching the pair of split pipe treatment systems. The water was allowed to flow back down the split pipe before being discharged into the concrete storm box where the initial turbidity problem had come from.
