## Applied Polymer Systems, Inc.

# Innovations

In Water Clarification

## Kentucky Lake Spring 2007

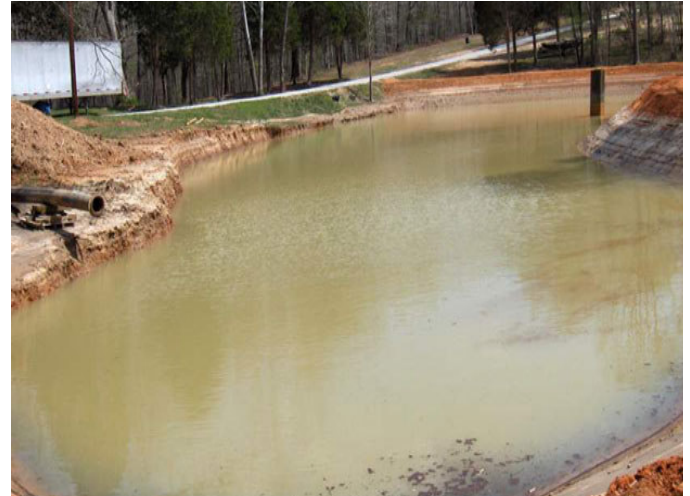
**The dredge spoils discharged into the stilling pond through the pipe on the left and discharged through the riser pipe on the right.**

The plan was to dredge out the cove and deposit the spoils into a large stilling pond where the sediment would settle out. The excess water would discharge from the pond, filter through a wooded area, and eventually return to the lake. The wooded land belonged to the Tennessee Valley Authority (TVA), and they had the project shut down over concerns of elevated sediment loads in the water returning to the lake as well as erosion through the woods due to the high volume and velocity of the discharged water.

The dredge spoils entered the stilling basin with 15% solids. Within the stilling basin the heavy sediment (silt and sands) dropped out of suspension. However the water was still cloudy as the colloidal clays and fine sediment were still in suspension. The turbidity of the water discharging from the stilling basin through the riser pipe was measured at 500-600 NTU. As the turbid water reacted with the Floc Logs in the treatment system, and the reacted particulate was collected, the fine sediment and clays were removed and the turbidity dropped drastically to only 21.0 NTU. The clarified water slowly filtered through the remainder of the wooded area and reentered Kentucky Lake without any turbidity plumes.

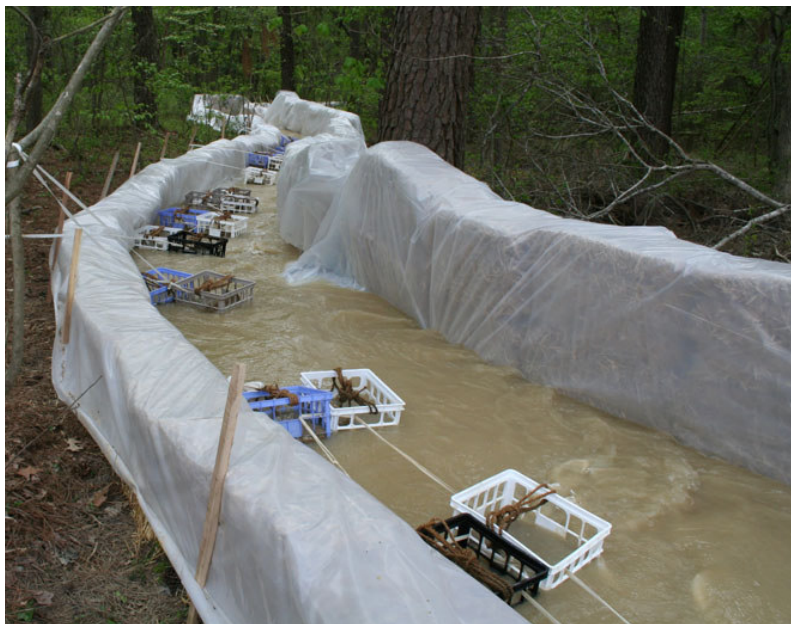
**The soil-specific Floc Logs were secured into plastic crates in the mixing/reaction portion of the treatment system where the polymer would react with suspended sediment.**

The mixing/reaction portion of the treatment ditch was placed at the outlet of the riser pipe, and was constructed with two rows of straw bales placed 4-5 feet apart and covered with plastic sheeting. The mixing ditch was 140 feet long, and was built on top of a layer of geotextile fabric to protect the plastic sheeting from punctures.

The site-specific Floc Logs were secured in plastic crates and placed in a series running down the treatment ditch. The turbulence caused by the narrow ditch and the high flow rate ensured that the turbid water could flow over and around the Floc Logs allowing for dissolution. The dissolving polymer mixed and reacted with the suspended sediment, binding together to cause large particulate to form. The turbulence along the ditchline increased the mixing which increased the particle size and pulling the fine sediment and swelling clays out of suspension.

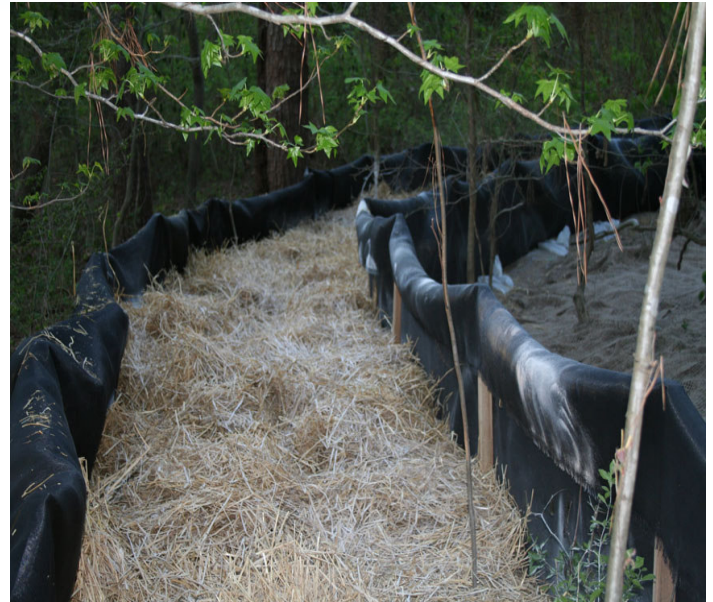
**The treated water passed across the jute dispersion field before passing through the sediment retention barrier filled with straw and polymer where final polishing occurred.**

The dispersion field was stabilized with a Soft Armoring technique. Open-weave jute matting was laid in the dispersion field and applied with the appropriate soil-specific Silt Stop powder. The jute fabric provided a surface area for the reacted particulate to adhere to while providing structural support to the underlying soil surface to prevent erosion. The Silt Stop powder enhanced the particle collection capabilities of the jute matting and bound the jute matting to the soil surface to prevent cutting in the forest floor.

The treated water spread out and slowed down as it was discharged into the 8,100 sq. ft. dispersion field, ringed by a polymer enhanced Sediment Retention Barrier (SRB). The water pooled in the dispersion field, slowly filtering through the SRB and releasing at a greatly reduced velocity and returned to Kentucky Lake.

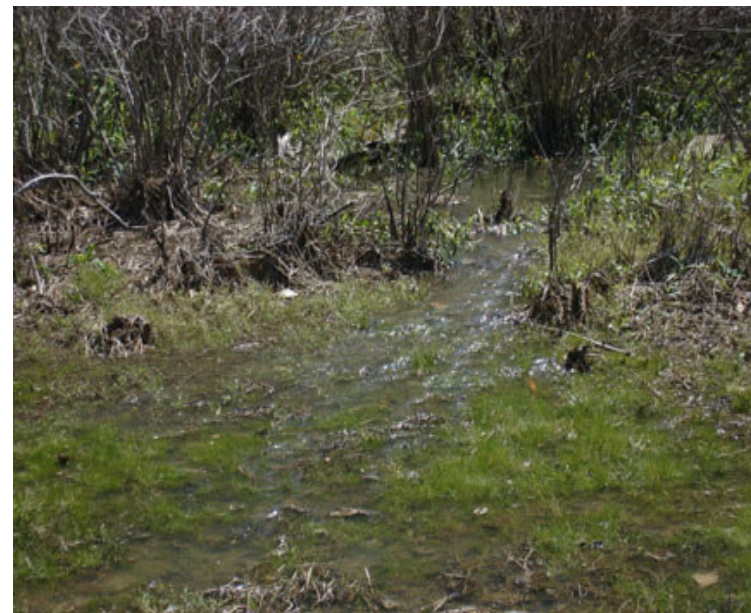
**The clarified water re-entered Kentucky Lake without any turbidity impacts.**
