Applied Polymer Systems, Inc.

Innovations

In Water Clarification

Kentucky Lake Spring 2007

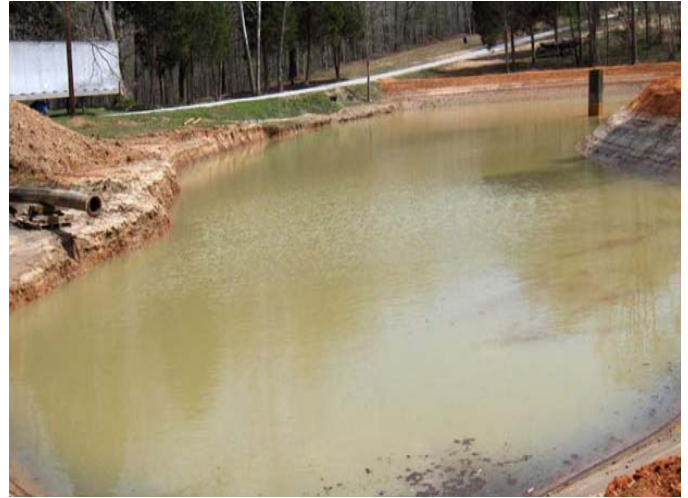
The dredge spoils discharged into the stilling pond through the pipe on the left and discharged through the riser pipe on the right.

The dredge spoils entered the stilling basin with 15% solids. Within the stilling basin the heavy sediment (silt and sands) dropped out of suspension. However the water was still cloudy as the colloidal clays and fine sediment were still in suspension. The turbidity of the water discharging from the stilling basin through the riser pipe was measured at 500-600 NTU. As the turbid water reacted with the Floc Logs in the treatment system, and the reacted particulate was collected, the fine sediment and clays were removed and the turbidity dropped drastically to only 21.0 NTU. The clarified water slowly filtered through the remainder of the wooded area and reentered Kentucky Lake without any turbidity plumes.

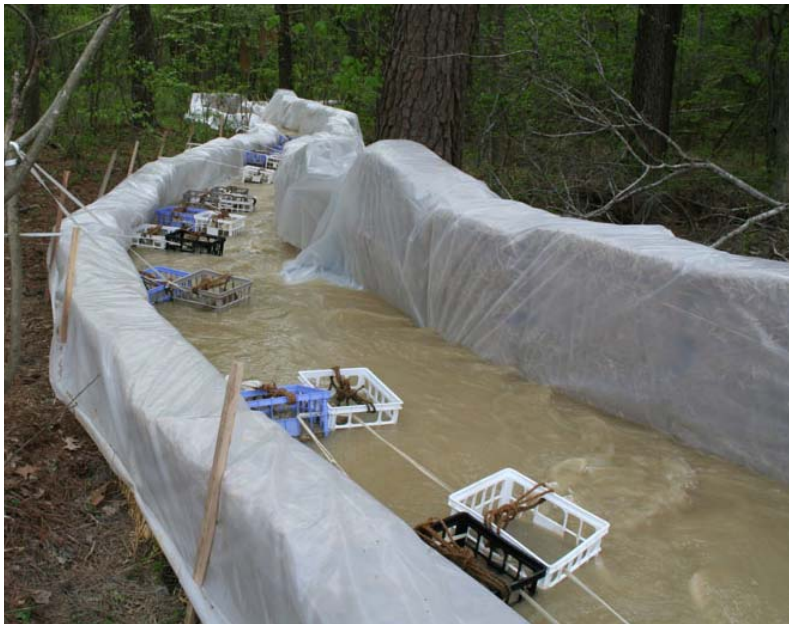
The soil-specific Floc Logs were secured into plastic crates in the mixing/reaction portion of the treatment system where the polymer would react with suspended sediment.

The mixing/reaction portion of the treatment ditch was placed at the outlet of the riser pipe, and was constructed with two rows of straw bales placed 4-5 feet apart and covered with plastic sheeting. The mixing ditch was 140 feet long, and was built on top of a layer of geotextile fabric to protect the plastic sheeting from punctures.

The site-specific Floc Logs were secured in plastic crates and placed in a series running down the treatment ditch. The turbulence caused by the narrow ditch and the high flow rate ensured that the turbid water could flow over and around the Floc Logs allowing for dissolution. The dissolving polymer mixed and reacted with the suspended sediment, causing particles to form. The turbulence along the ditchline increased the mixing and allowed the particulate to build up and collect the fine sediment and swelling clays.

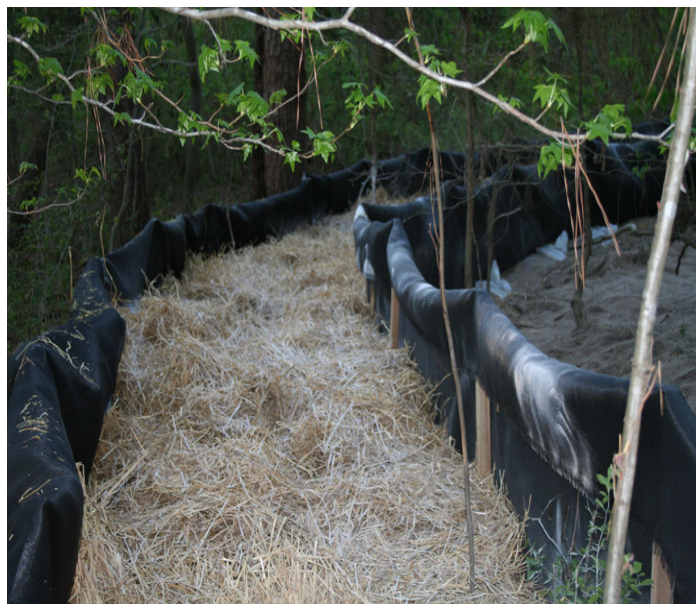
The treated water passed across the jute dispersion field before passing through the sediment retention barrier filled with straw and polymer where final polishing occurred.

The treatment ditch discharged into a dispersion field lined with open weave jute matting applied with the appropriate soil-specific Silt Stop powder. The jute fabric provided a surface area for the reacted particulate to adhere to while providing structural support to the underlying soil surface to prevent erosion or cutting in the forest floor. The Silt Stop powder enhanced the particle collection capabilities of the jute matting. The water spread out and slowed down as it was discharged into the 8,100 sq. ft. dispersion field, ringed by a polymer enhanced Sediment Retention Barrier (SRB). The water pooled in the dispersion field, slowly filtering through the SRB and releasing at a greatly reduced velocity and returned to Kentucky Lake.

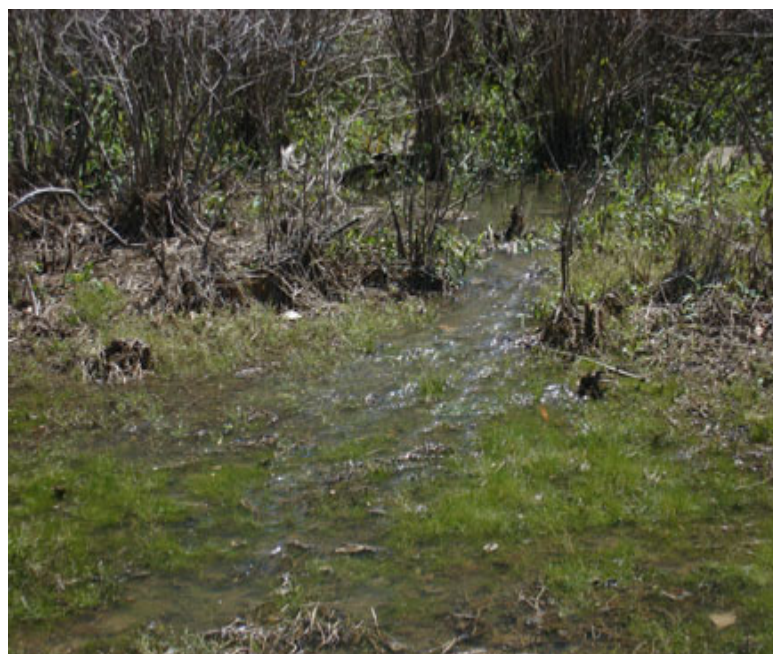
The clarified water re-entered Kentucky Lake without any turbidity impacts.

After treatment and clarification, the water discharged into a dispersion field where it spreads out and slowed down in a stabilized area before being allowed to re-enter Kentucky Lake. The particles that had formed in the reaction portion were collected and removed, allowing clarified water to return to the lake. By reducing the velocity, the erosive potential of the flowing water was greatly reduced to minimize the disturbance to the vegetated areas.
