Applied Polymer Systems, Inc.

Innovations

Rolling M Ranch Pond Clean Up

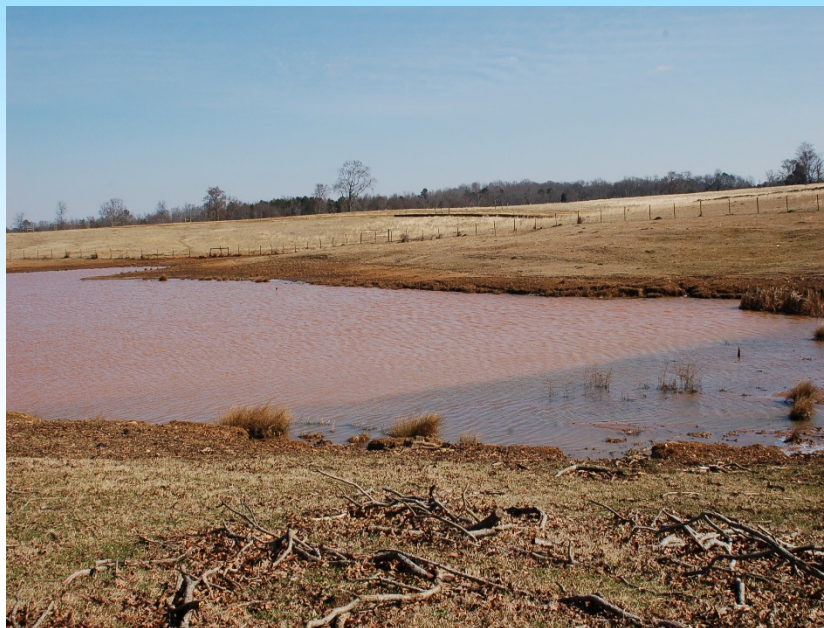
Marion McHugh, owner of Rolling M Ranch, was very concerned about the turbidity in his pond because his cattle were drinking the water and getting sick. Mr. McHugh contacted Erosion Tech to assist him with clearing the turbidity from the pond which, by that point, had reached 967 NTU.

Above: Rolling M Ranch pond before treatment, turbidity level over 900 NTU

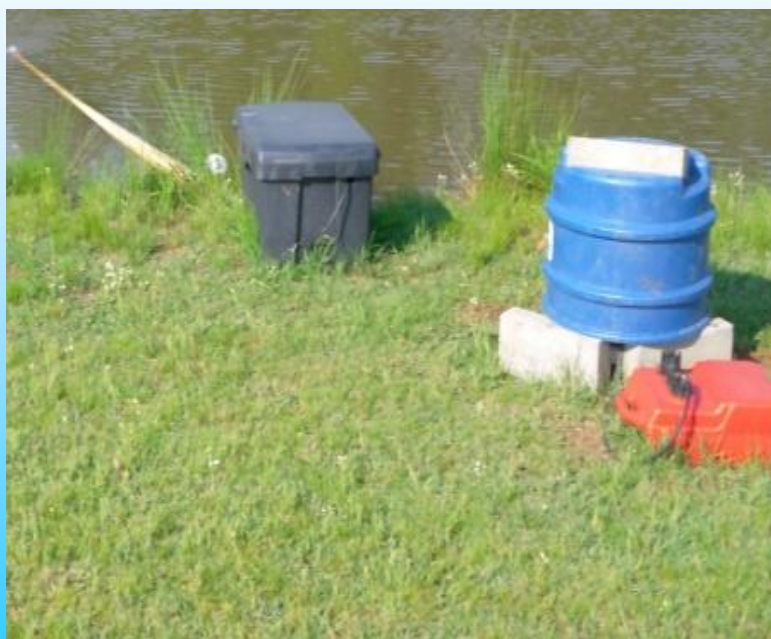
Below: The L.I.P.V.A.C. System from Eco Pond Rescue installed at Rolling M Ranch.

Erosion Tech's first idea was to use a dewatering ditch, lined with Floc Logs, to treat the water and discharge it back into the pond. Then they thought about trying the new L.I.P.V.A.C.S with Applied Polymer Systems, Inc. Floc Logs which successfully flocculate and remove phosphorous and nonliving nutrients.

This particular pond required the 703d#3 and 706b Floc Logs to clarify the water. The pond contained approximately 18 million gallons of water, which would require 18 of each Floc Log to successfully treat the system. The 706b and 703d#3 L.I.P.V.A.C Logs, and two (2) L.I.P.V.A.C.S. were installed in late March.

The L.I.P.V.A.C.S. ran for approximately 24 hours a day for about 30 days. After treatment the pond's NTU had been reduced from 967 to 14.

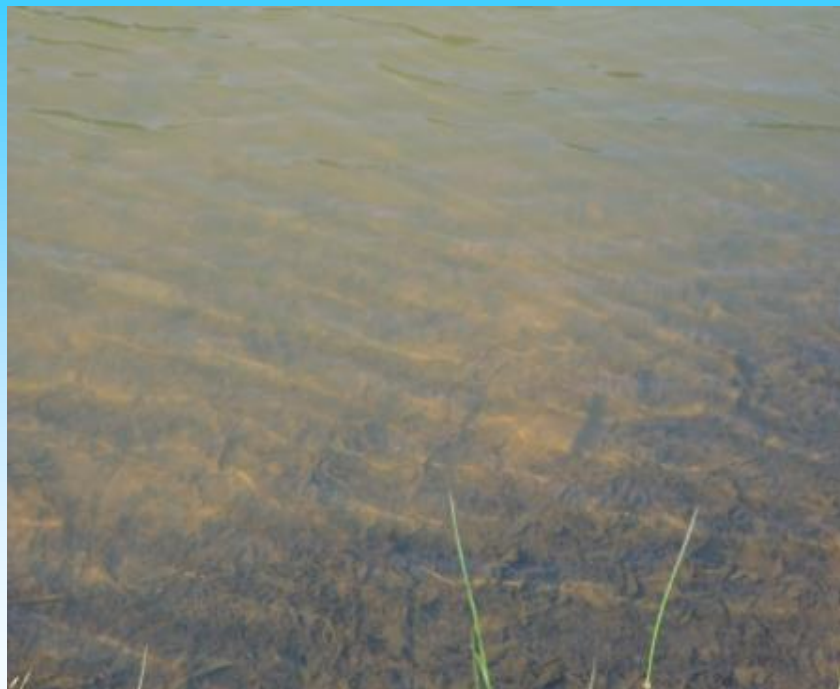
Above: The turbidity level of the pond has been reduced dramatically and now the bottom of the pond is visible in places.

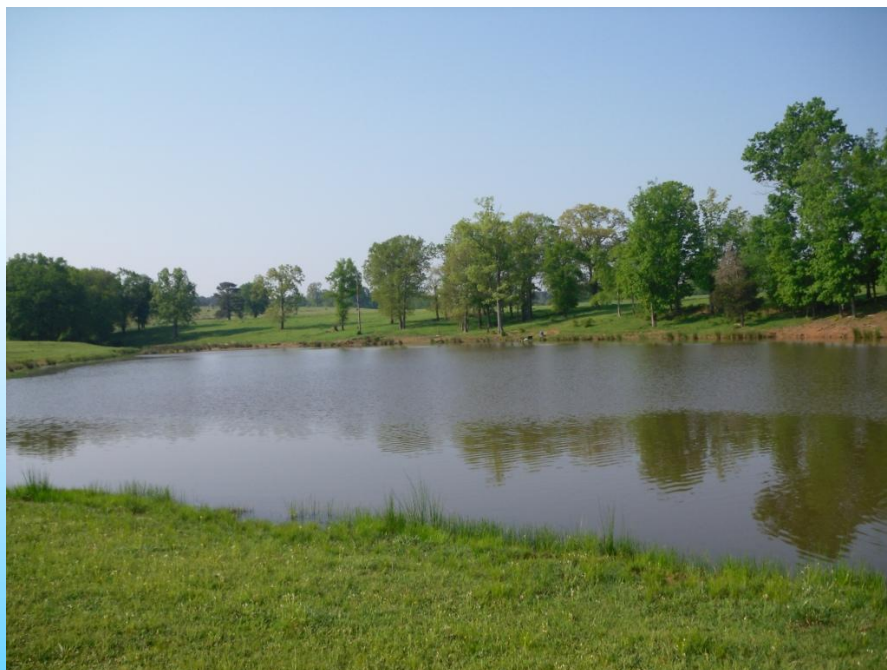
Below : After treatment with L.I.P.V.A.C. System and Logs, the turbidity level of the pond is now below 15 NTU.
